Dock Inspection Report

**Mrs. Bonnie Guenther
Conquistador Homeowner's Association**

Property Address:
1800 SE St Lucie Blvd
Stuart FL 34996

July 17th, 2021

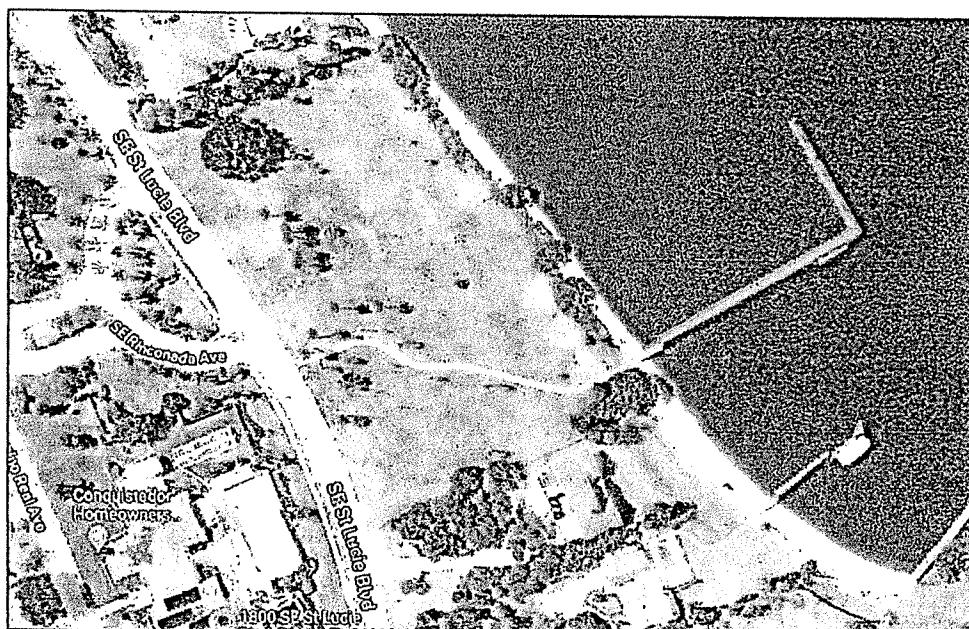
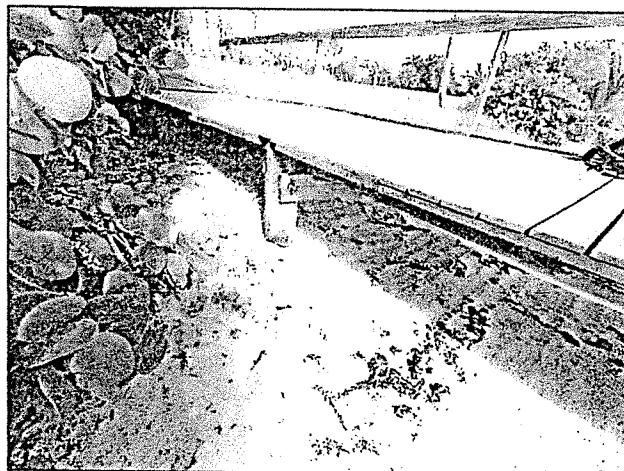
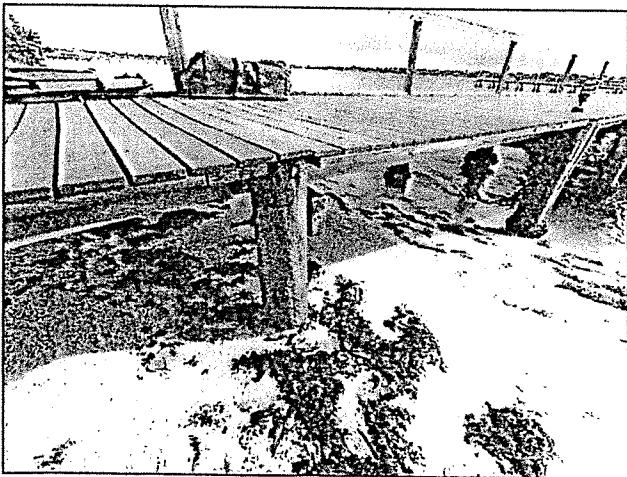
The property is located directly on the St. Lucie River in Stuart, FL. The grounds are characterized as an open lot, as in a park, with a sloped elevation dropping towards the shores off of the St. Lucie River.

The lot where the park is located appears to be professionally maintained and well kept. Inspector found no evidence of erosion or soil de-stabilization that could have an adverse effect on the dock.

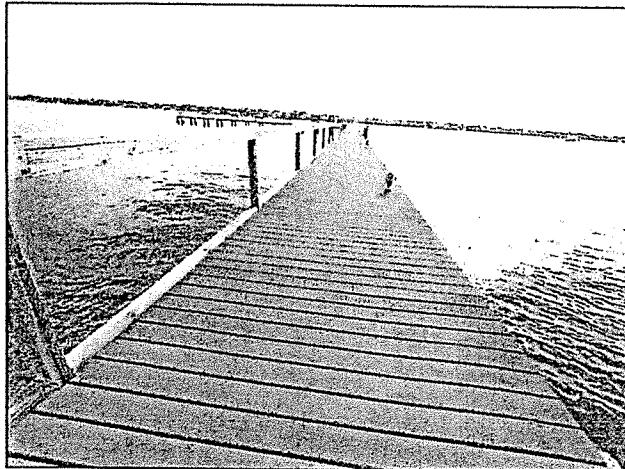
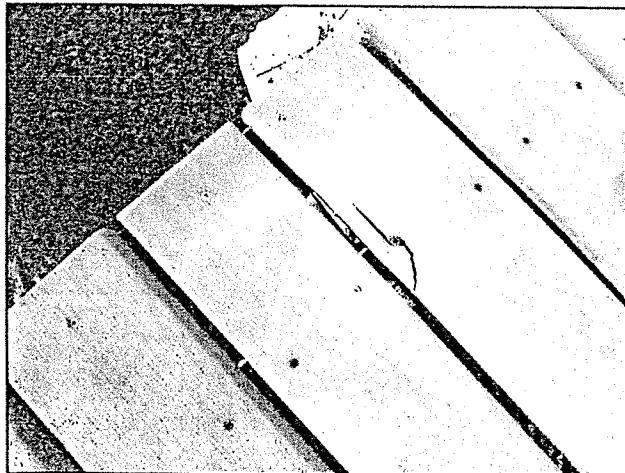
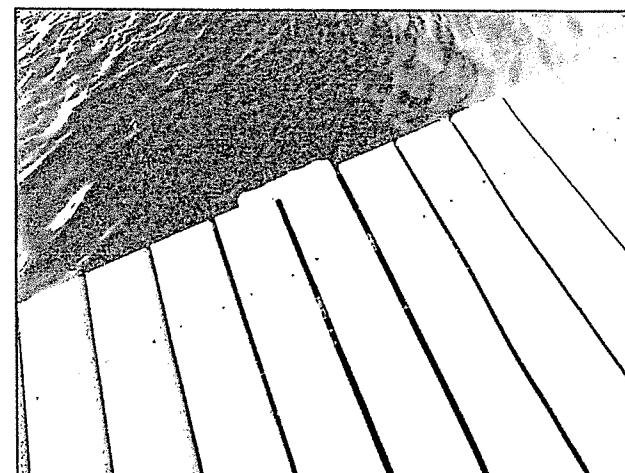
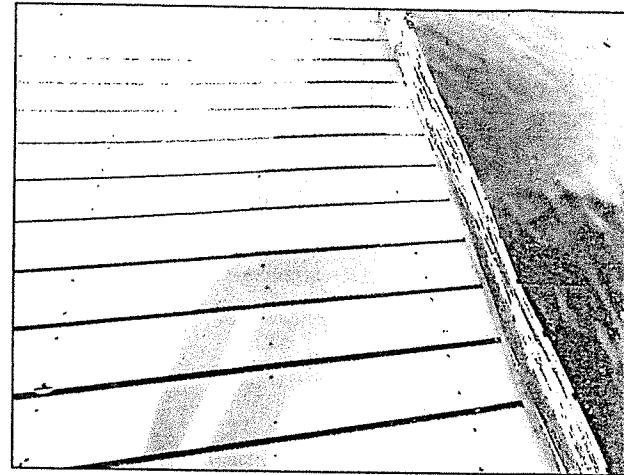
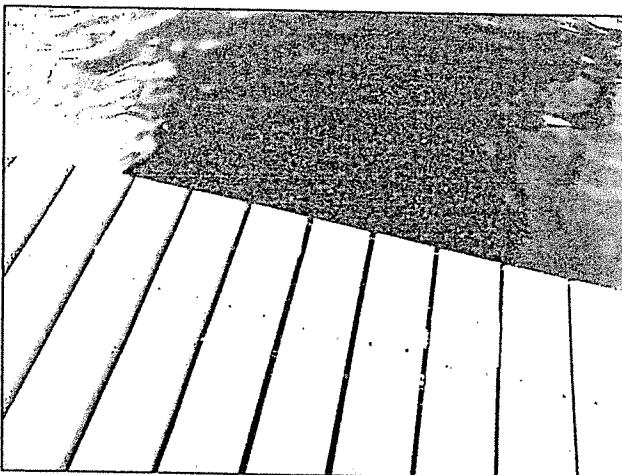
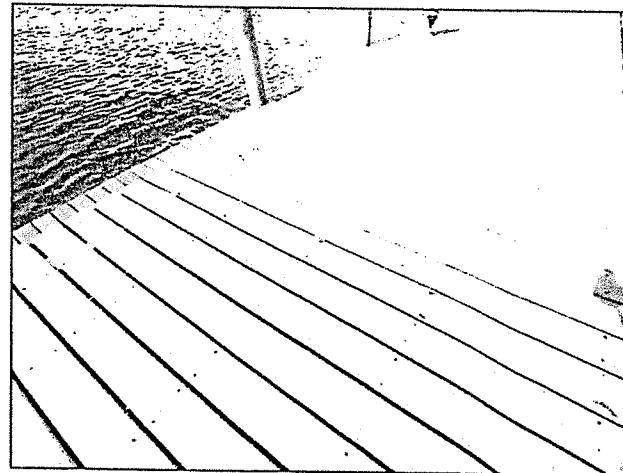
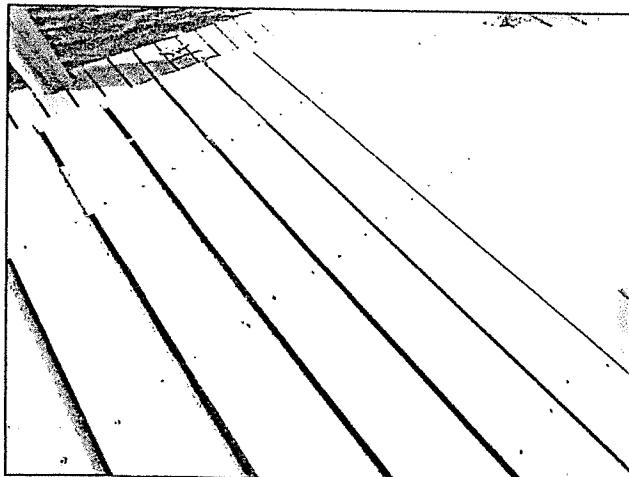
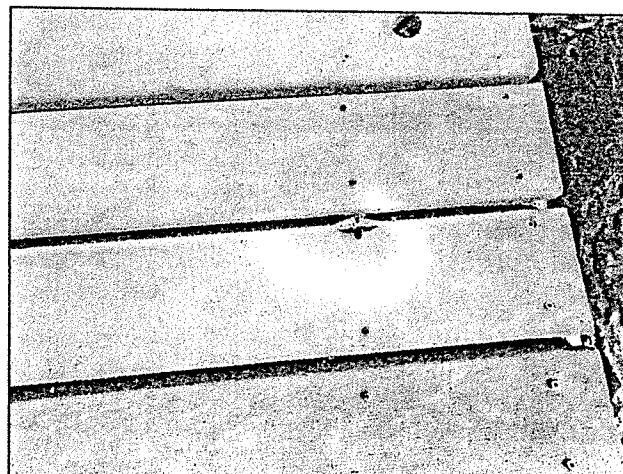
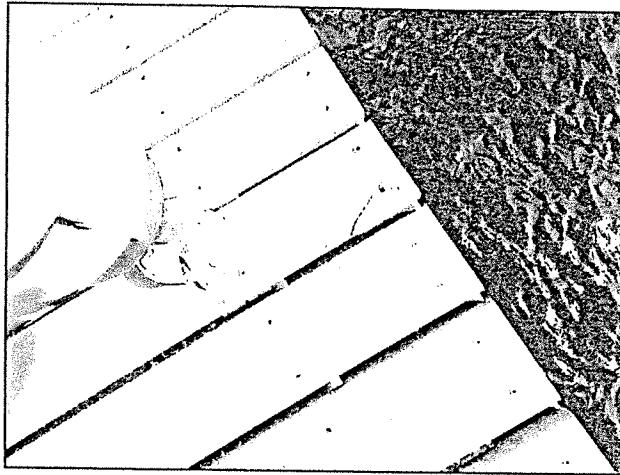
The dock measures +/- 400 lineal feet in length and is +/- 7 lineal feet wide. The deck is built with composite material and screwed in over marine lumber.

The deck exhibited minor signs of deterioration with some boards beginning to crack around some of the screws.

Some boards are not properly installed and not leveled with the rest of the deck. This is a trip hazard which should be corrected to prevent trip and fall accidents.

Also, there are several screw heads sticking out of the deck boards. Several screws are corroded as they stick out of the boards. This also represents a risk of injury and possible trip hazard.

Recommend repair or replacement of all damaged deck boards, re-placement of corroded screws, and re-tightening of all deck boards.

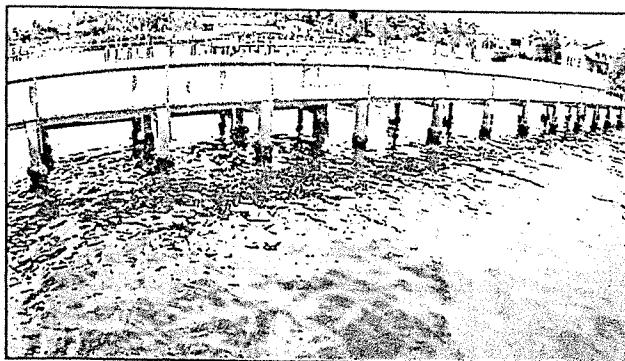
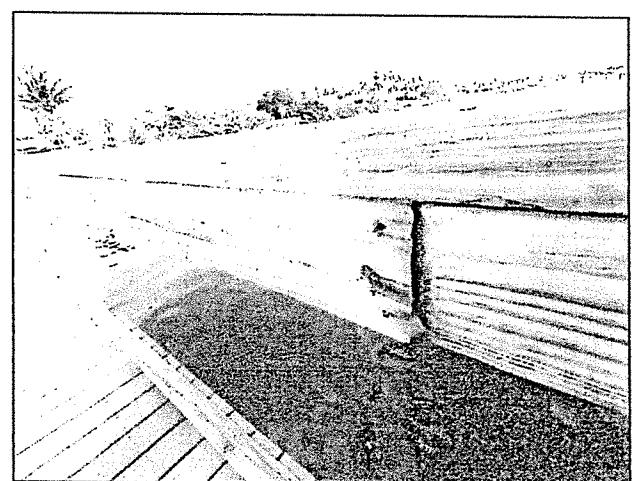
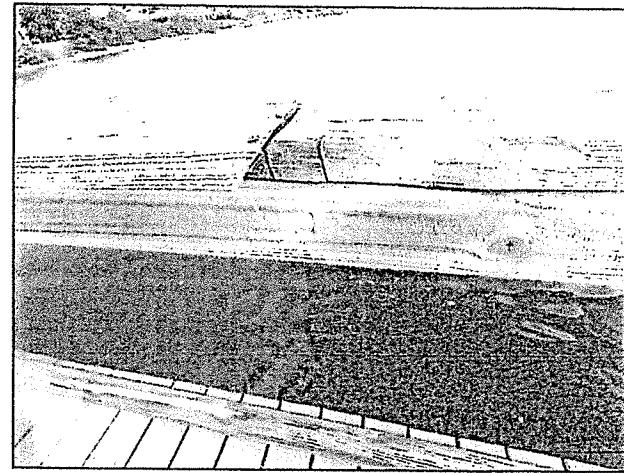
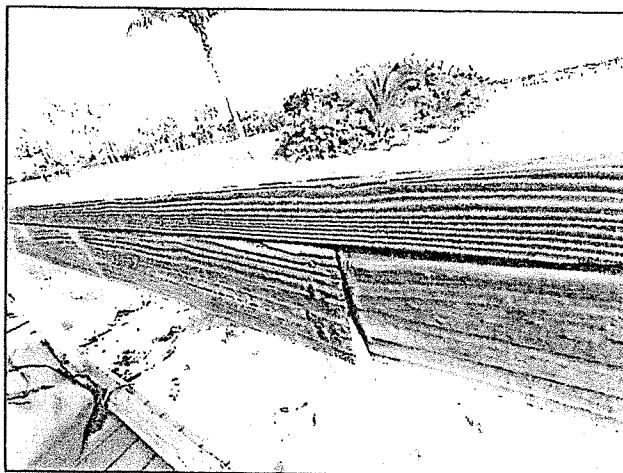
There is a wood deck rail on the entire left extension of the dock. The wood is very old and exhibited moderate levels of deterioration due to exposure to weather and sun.

Inspector found that several deck railing joints were separating or splitting. This represents a risk as people can get insured by corroded screws and splinters.

Inspector also found that a large portion of the railing was loose. The area is represented by the first 160 lineal feet of deck railing.

Recommend repair or replacement of all deck railings where the joints are separating, torn, or has corroded screws. Recommend repair or replacement of the section of railing that is loose. Recommend application of deck painting once every couple of years to extend the life of the wood railings.

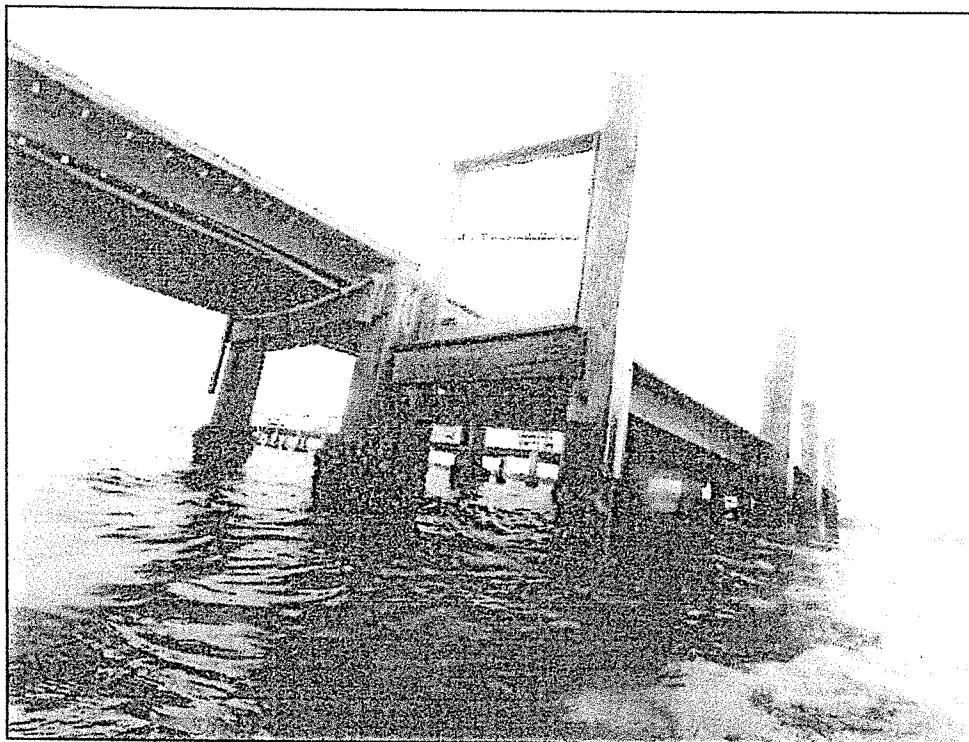
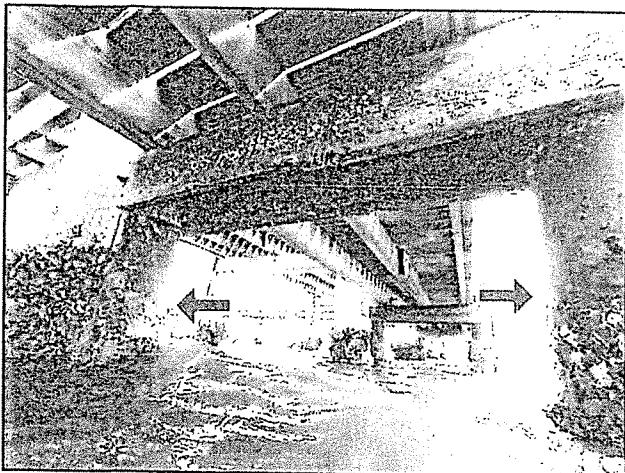
Vertical wood piling are the vertical supports for wood docks. There are some wood piles installed on this dock. The vertical piling can be damaged due to marine borers infestation. To extend the life of the wood piling, marine contractors uses a high-density polyethylene piling wrap. The wood piles on this section of dock are protected and are still in serviceable condition.

There are also some wood piles installed at the end of the dock to serve as temporary support for old concrete piles that collapsed. Those wood piles are intended to be temporary and should not be considered as permanent solution. Recommend those wood piles be removed and replaced by qualified marine contractor.

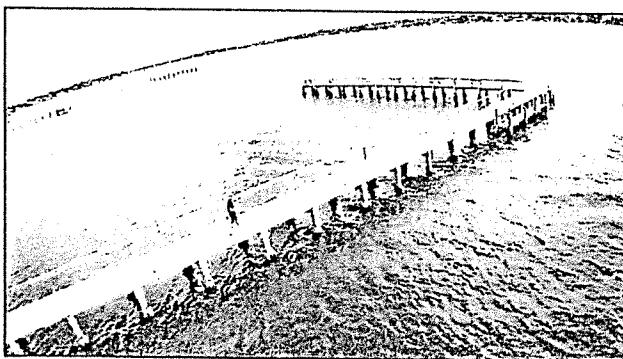
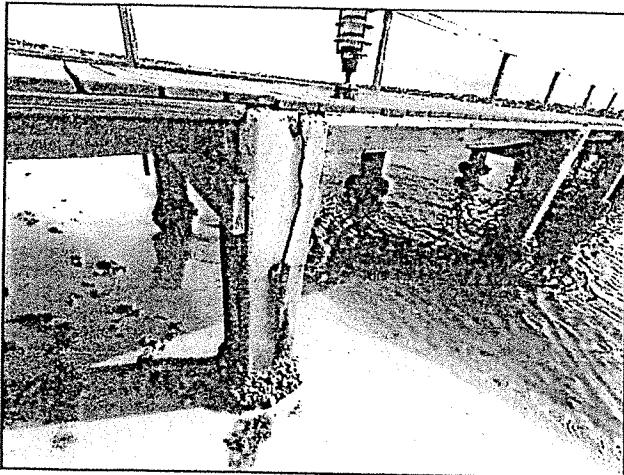
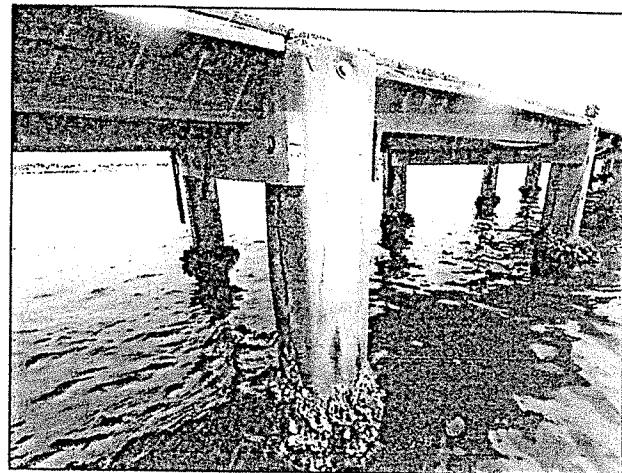
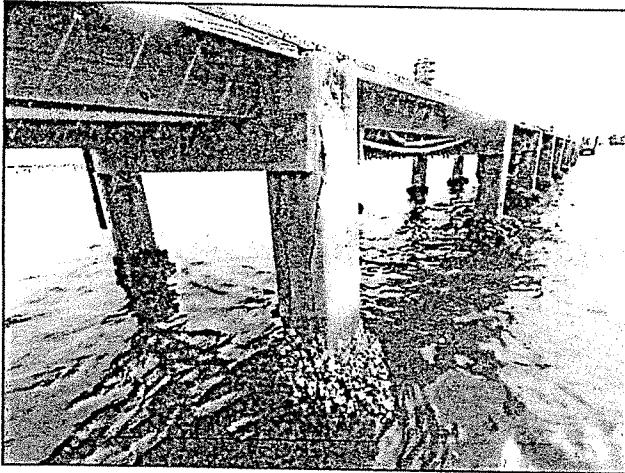
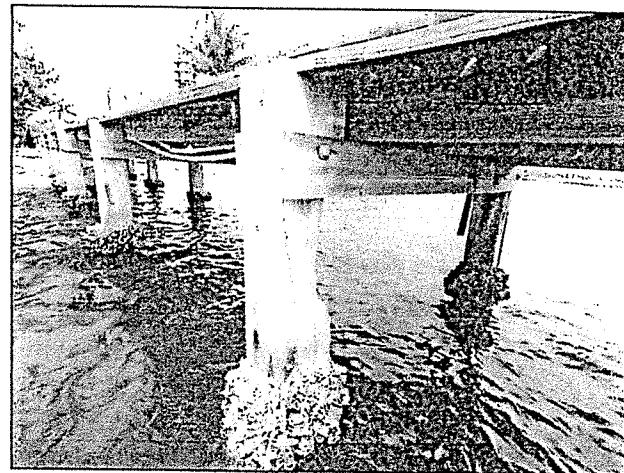
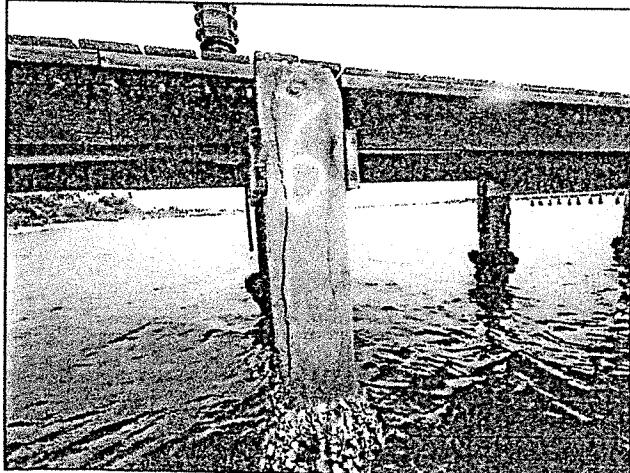
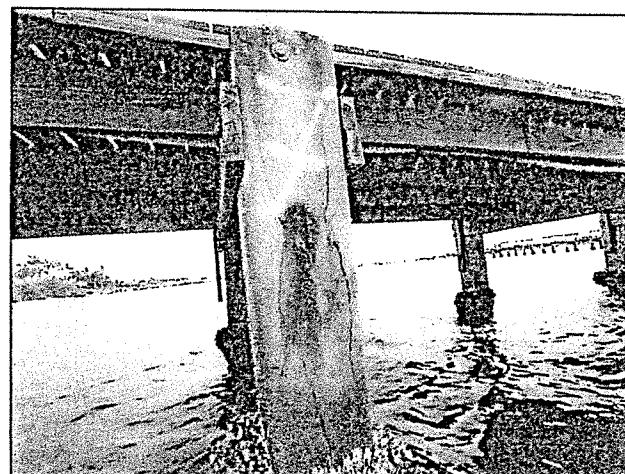
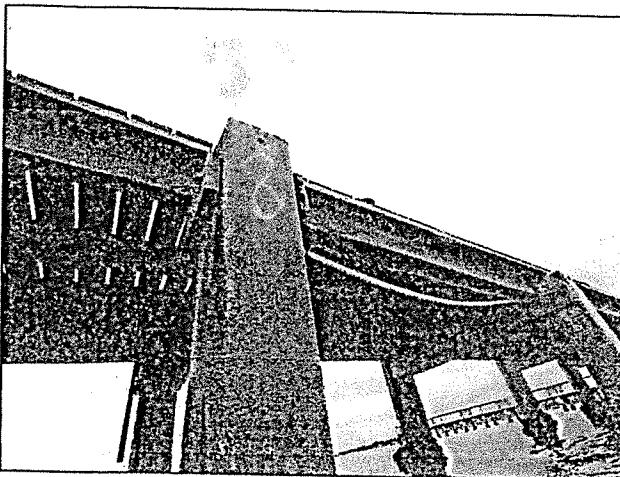
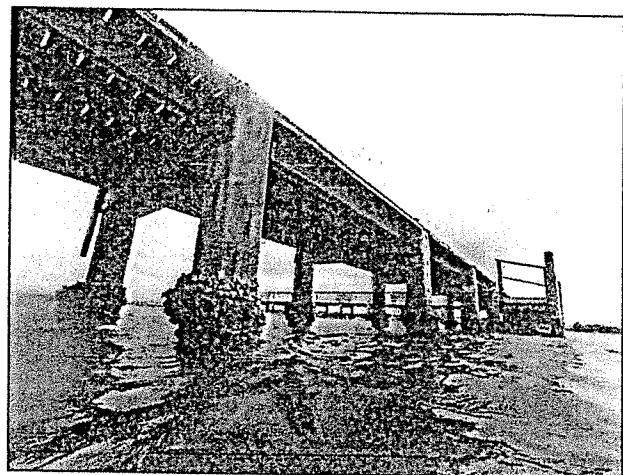
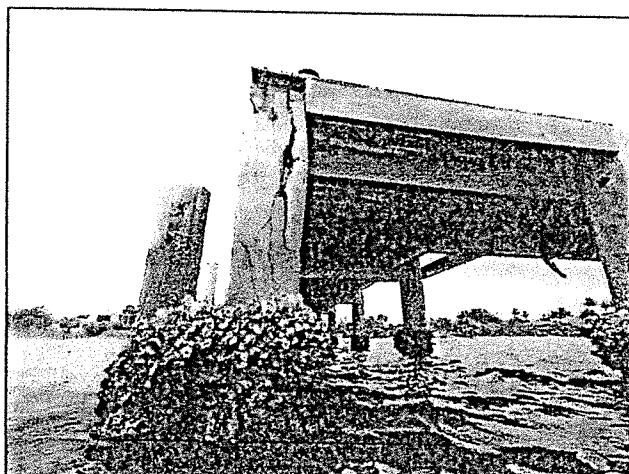
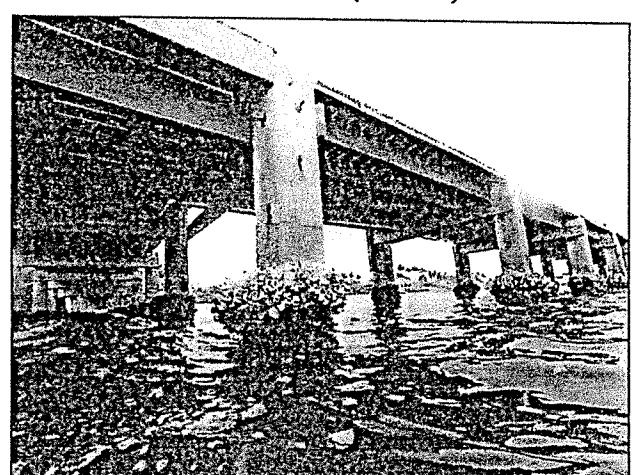
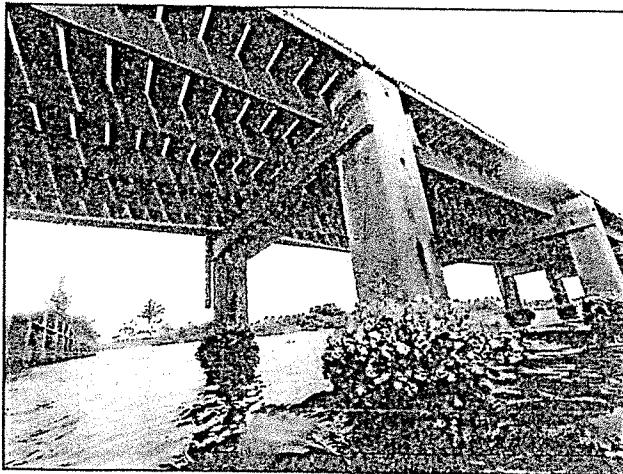
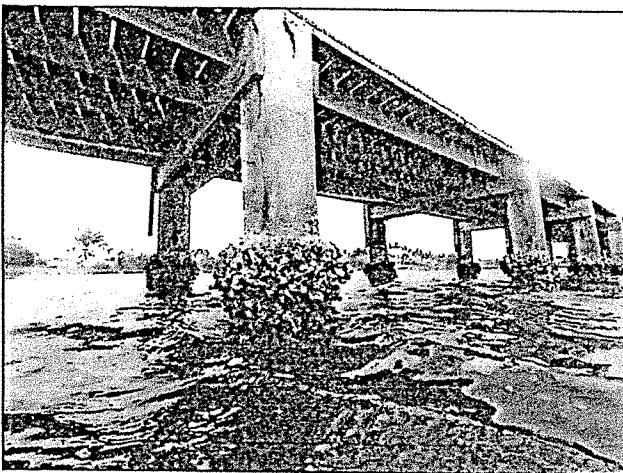
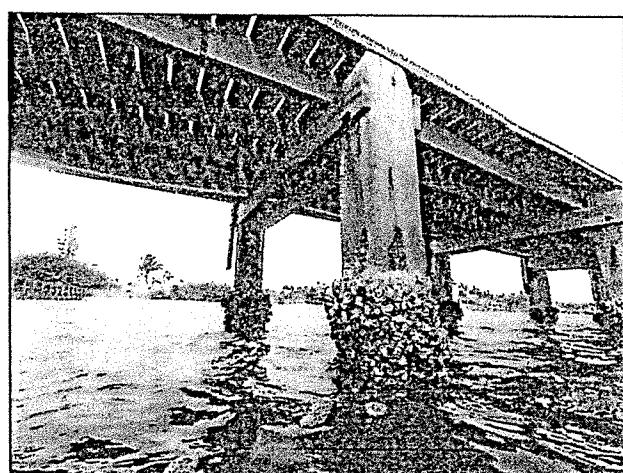
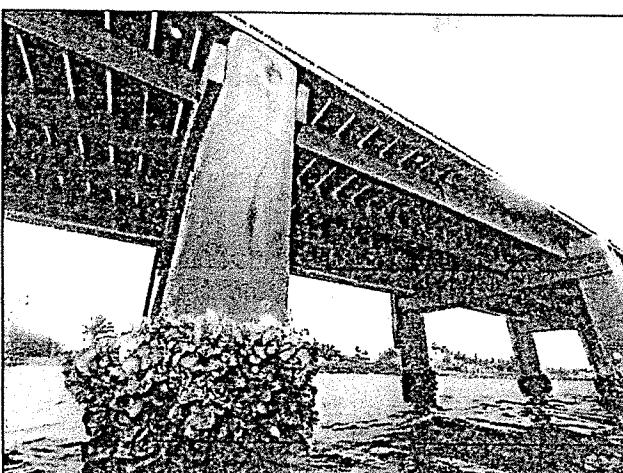
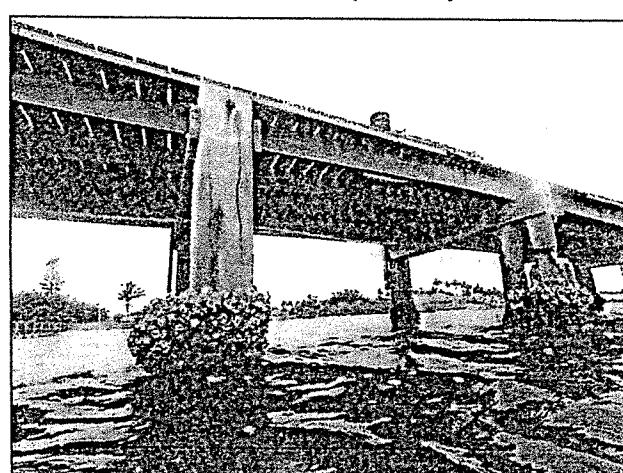
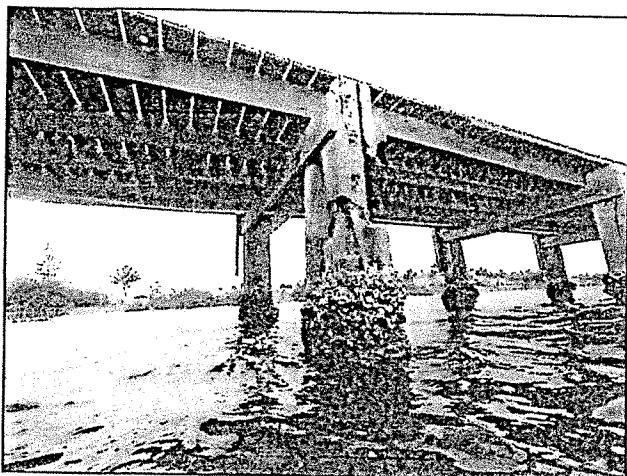
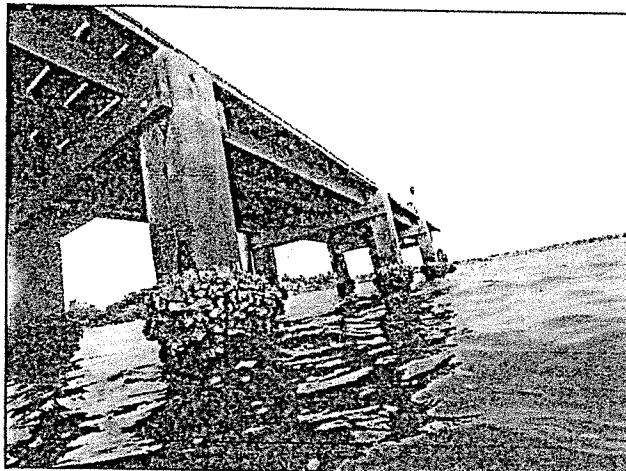
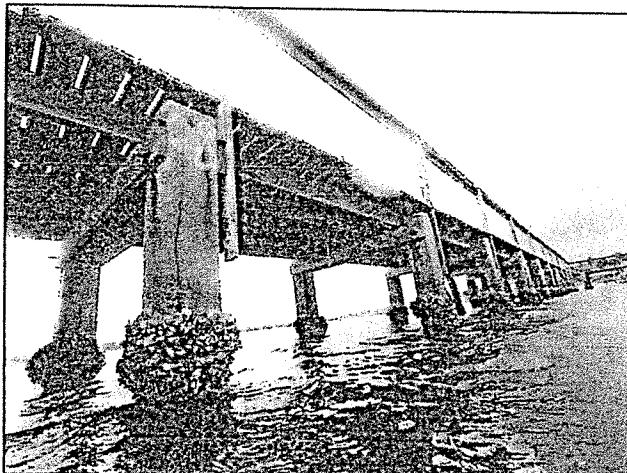
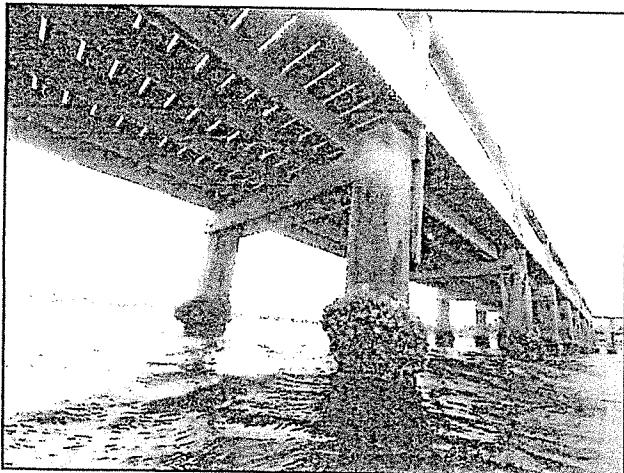
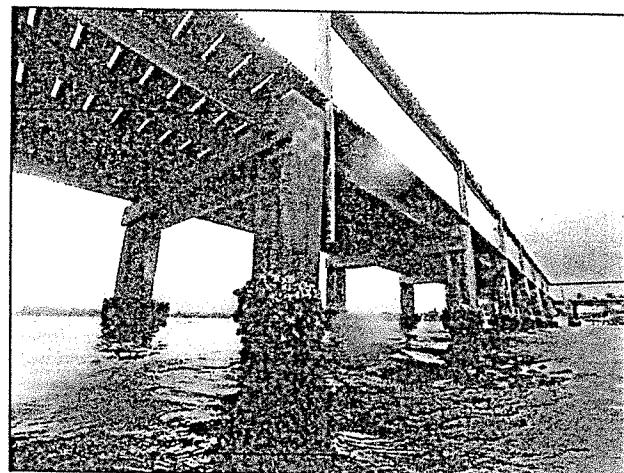
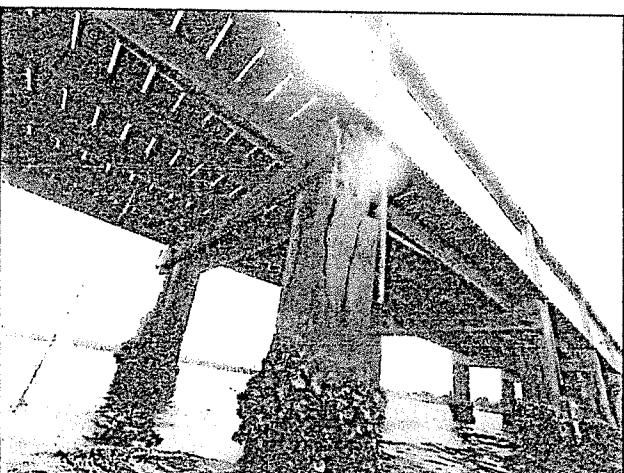
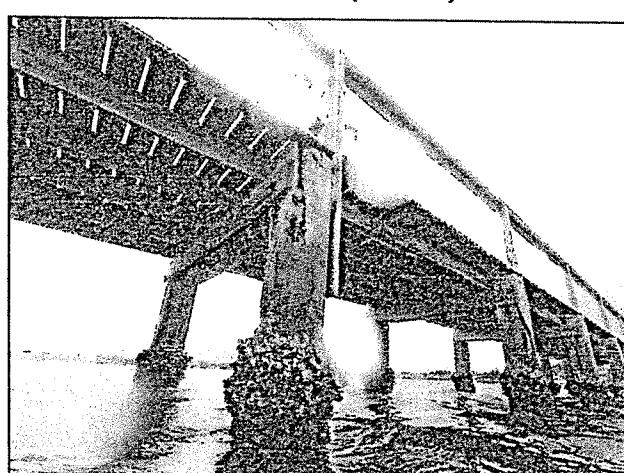
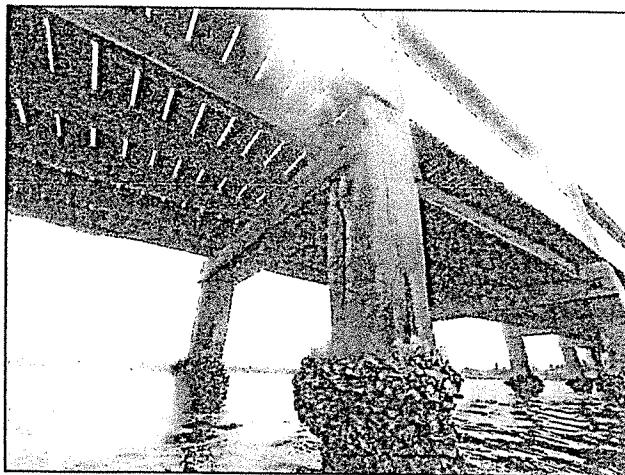
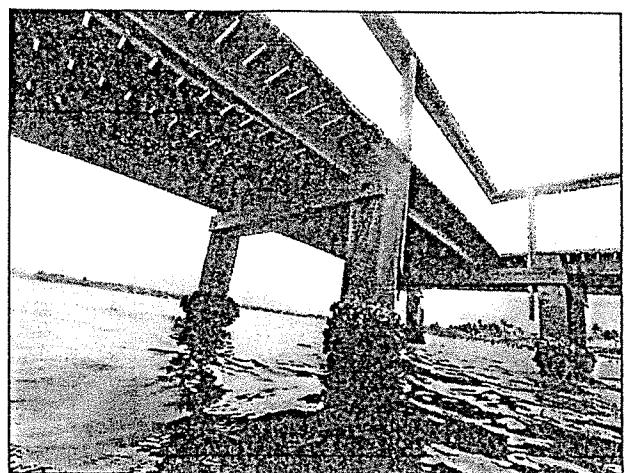
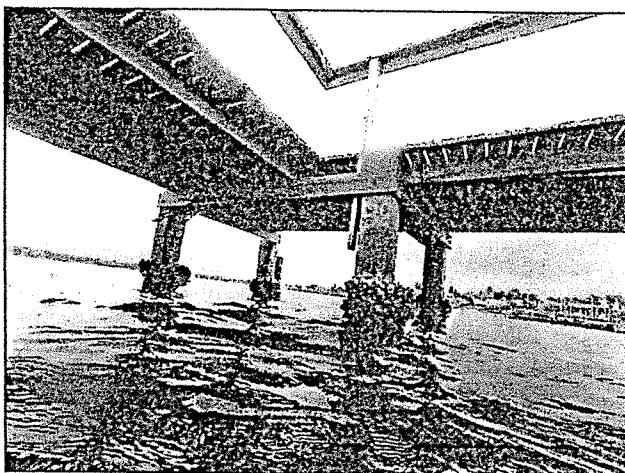
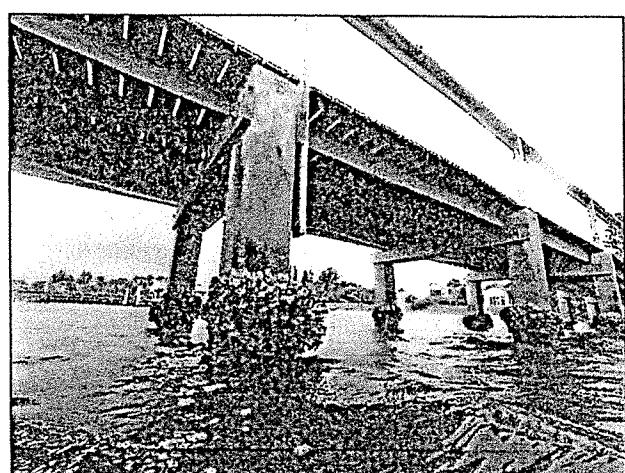
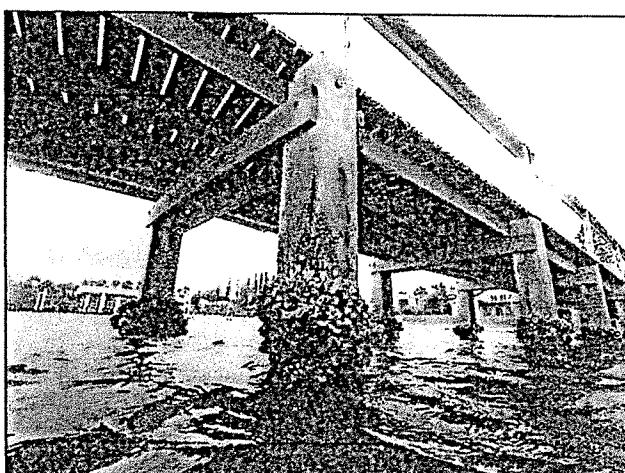
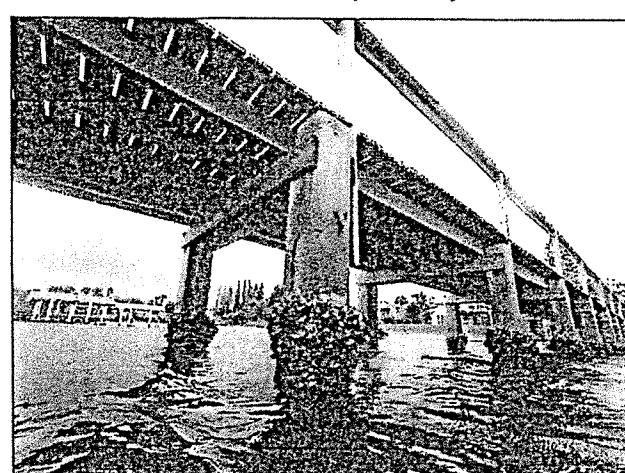
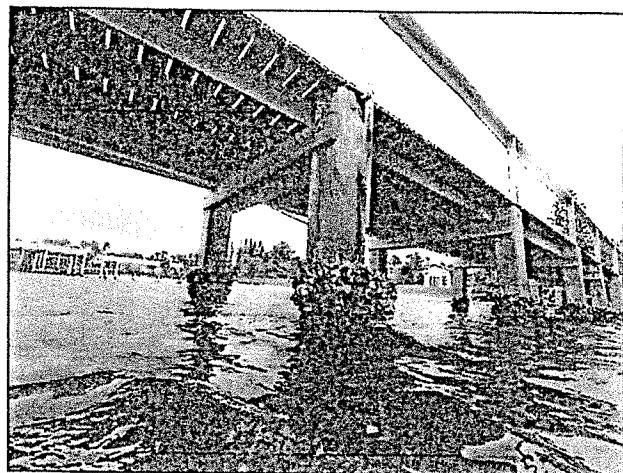
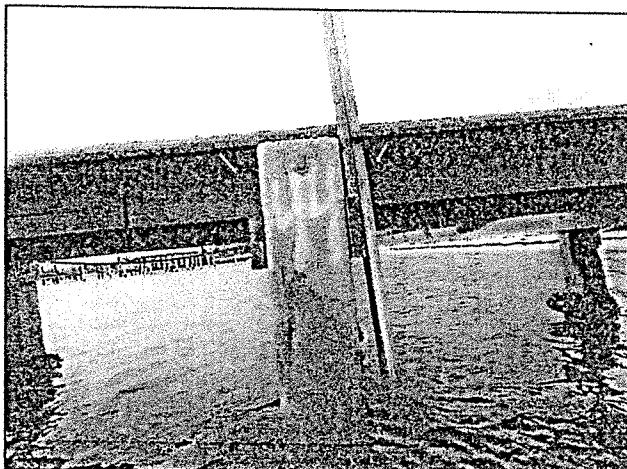
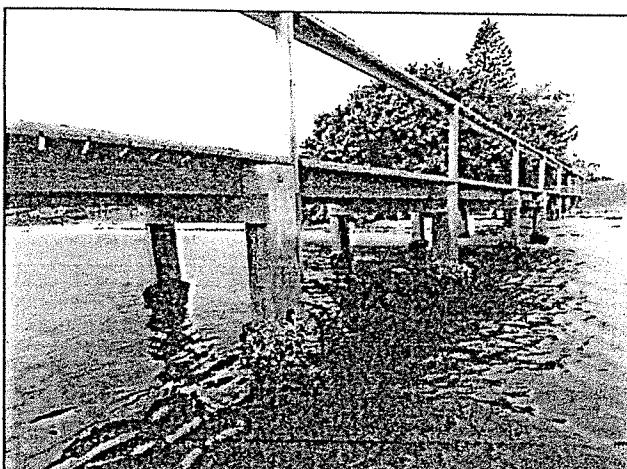
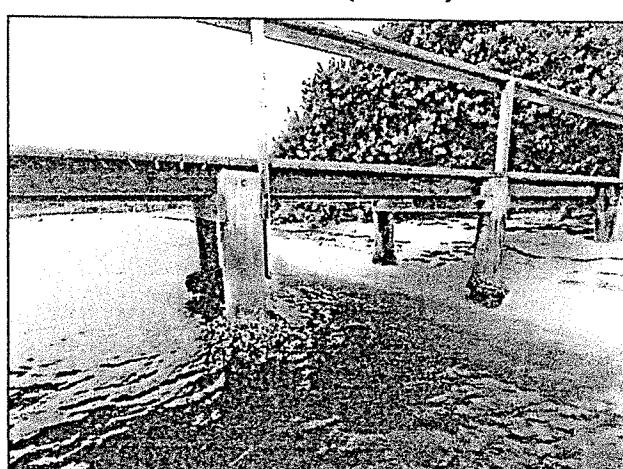
This dock was built with concrete piles that measures 12" x 12" and varies in length. What concrete piles gain in strength, when compared to wood piles, they loose in flexibility. The concrete piles are buried deep into the bottom of the river.

The top of the concrete piles are exposed to the greatest amount of movement (pressure) caused by wave and wind action. Therefore, when the dock moves (or is shaken), due to effects of wave and wind action, the concrete crack and expose the steel rebars inside. When left unattended for long periods of time, the steel rebar corrodes and expands causing further deterioration and weakening of the structure.

There are approximately 76 concrete piles supporting this 400 lineal feet dock. Inspector counted 49 of them in severe stage of deterioration. Most of the damaged concrete piles are beyond repair and should be replaced in its entirety. All work should be performed by a qualified marine contractor.

The portion of the concrete piles that is underground and underwater can resist better to corrosion of the reinforced steel rods due to poor oxygen content. Visibility underwater was very limited and the concrete piles were covered by mussels.

The area around the water line, also known as the splash zone, was covered with mussels. Mussels should be periodically removed to prevent de-calcification of the concrete, safeguard health of residents in the event of a fall, and allow for better and regular visual assessments.

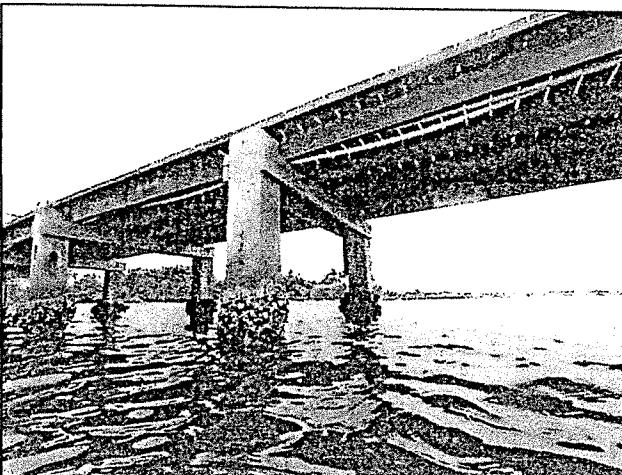
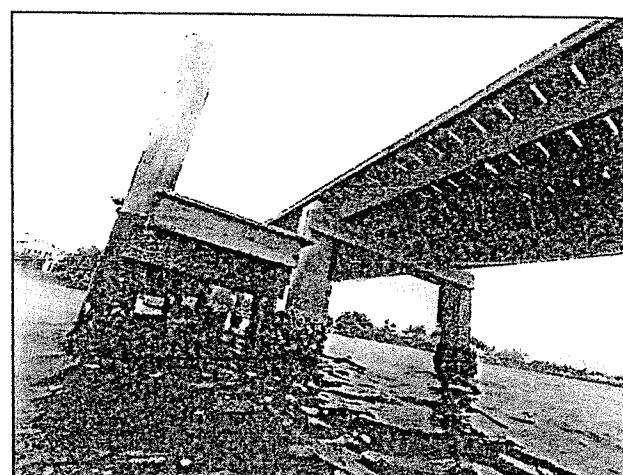
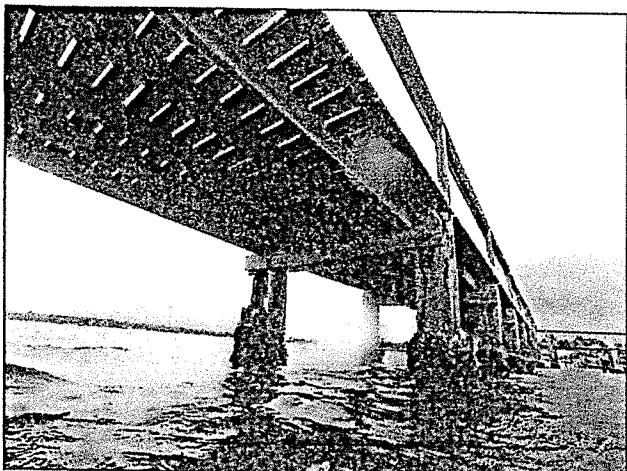
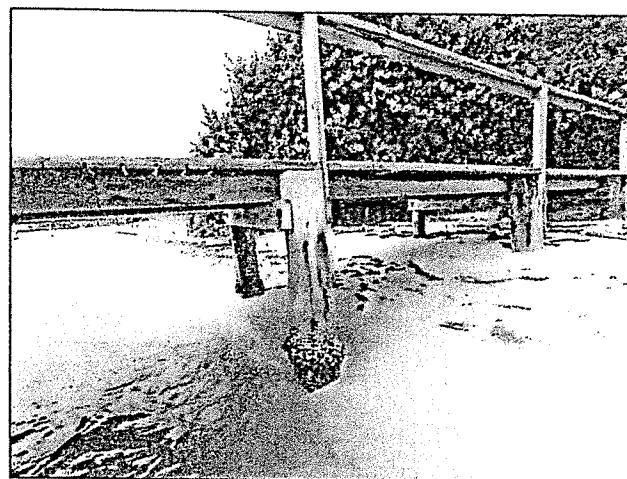
The beams are the underlying support to the deck planks. This composite deck boards are attached to three beams which are made of pressure treated marine lumber. Inspector found no deficiencies with the condition of the beams at the time of the inspection.

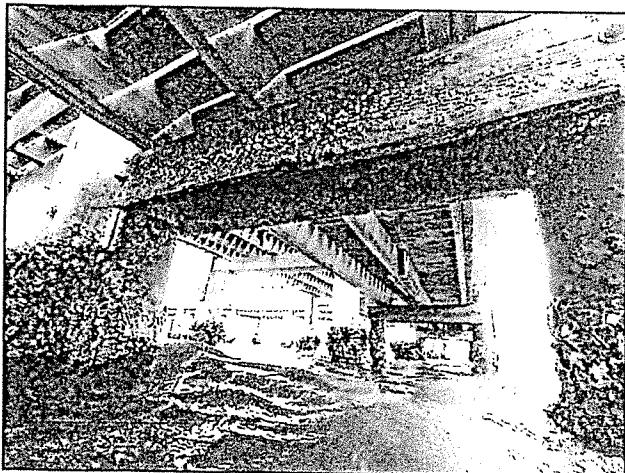
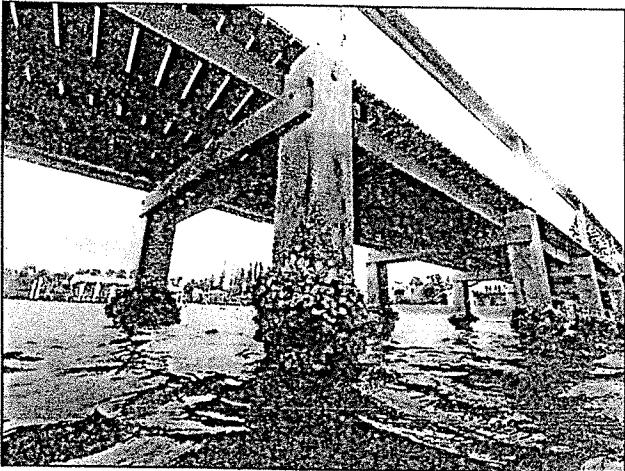
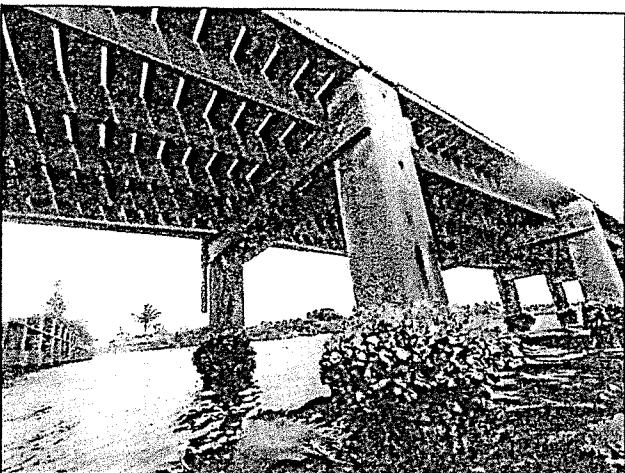
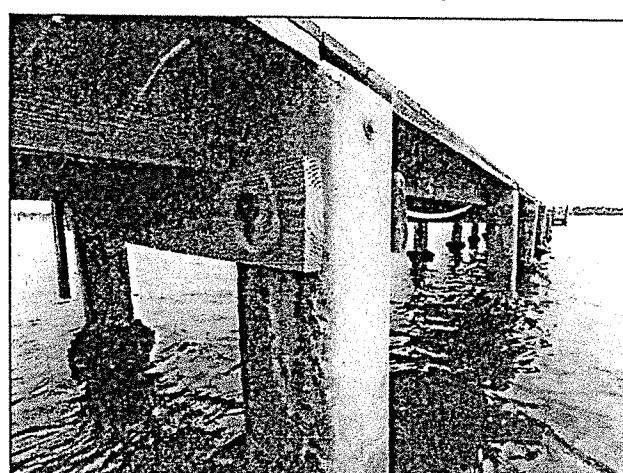
The beams are further supported by wood joists keeping the deck high from the water. Inspector found minor levels of deterioration of the wood joists caused mainly by corroded fasteners. The wood joists are in serviceable condition at this time.

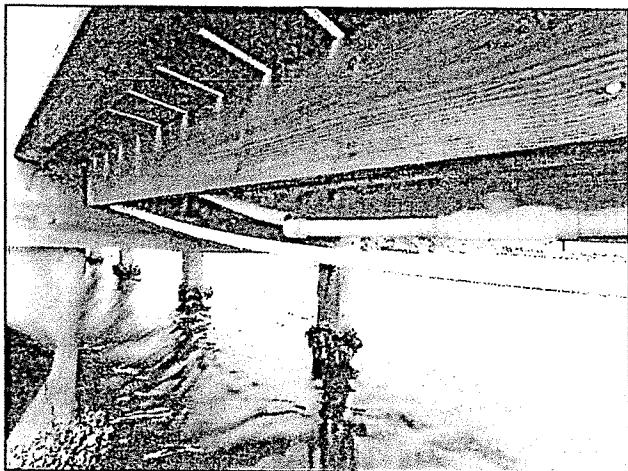
1.7 Item 1 (Picture)

The plumbing supply at the dock was poorly secured and it can break at any time. If it breaks you could lose a lot of water. Recommend securing the plumbing as soon as possible to prevent unexpected water loss.

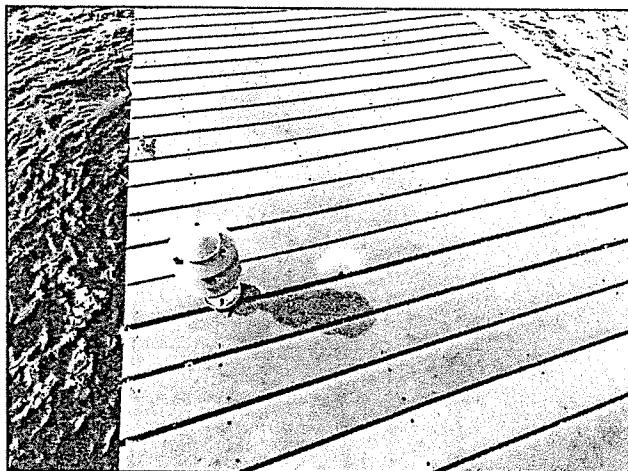
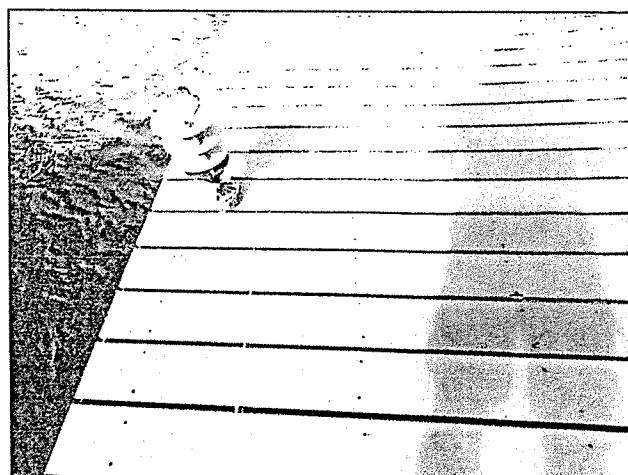
Some dock lighting was not functional at the time of the inspection. Recommend repairs.

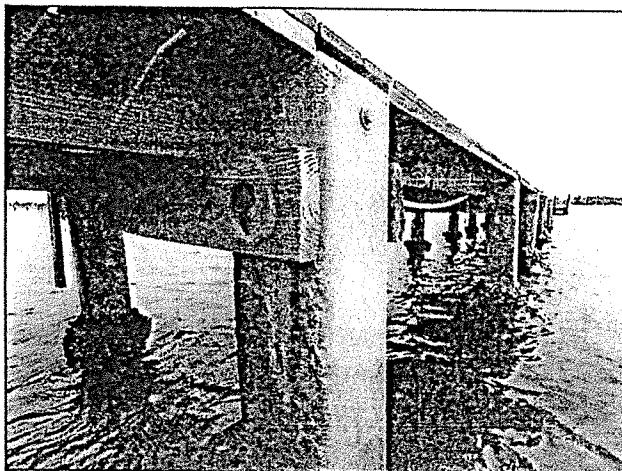
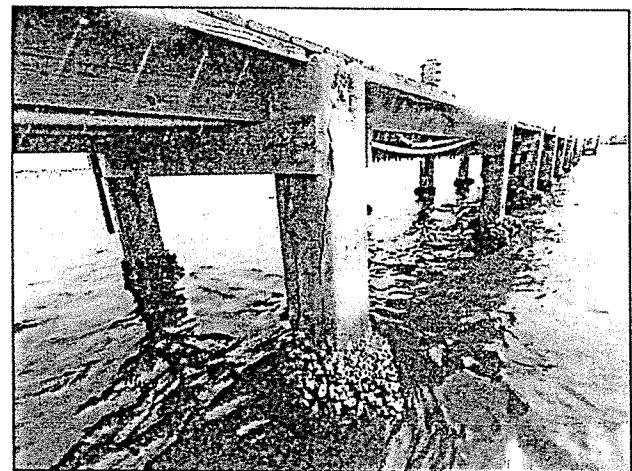
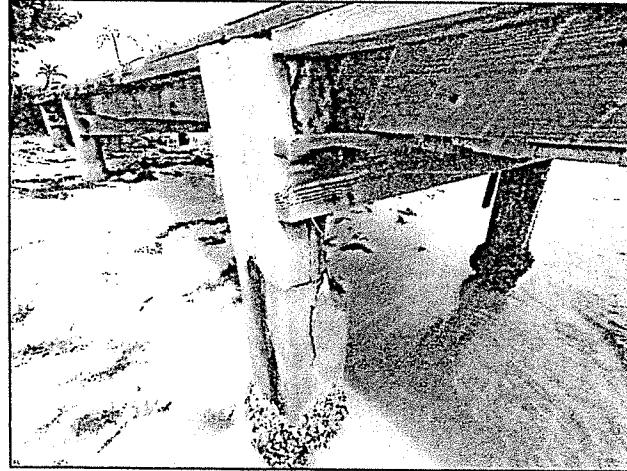
The joists are tied to the concrete piles with galvanized steel hardware such as nuts and bolts. Despite being galvanized, they don't last forever and will corrode. Several nuts and bolts were in advanced stage of deterioration and will need to be replaced.

Also, the beams were never strapped to the wood joists. When the beams are secured with straps or clips, you can maximize the ability of the dock to withstand the effects of strong force winds and wave action. Recommend that all beams be secured or re-enforced with stainless steel straps after you replace the damaged concrete piles.
