Visual Observation Report

August 31, 2022

RE: Flat Roof Observations for Clubhouse, Clubhouse Ancillary and Maintenance Buildings Located at 1800 SE St. Lucie Blvd., Stuart, FL 34996

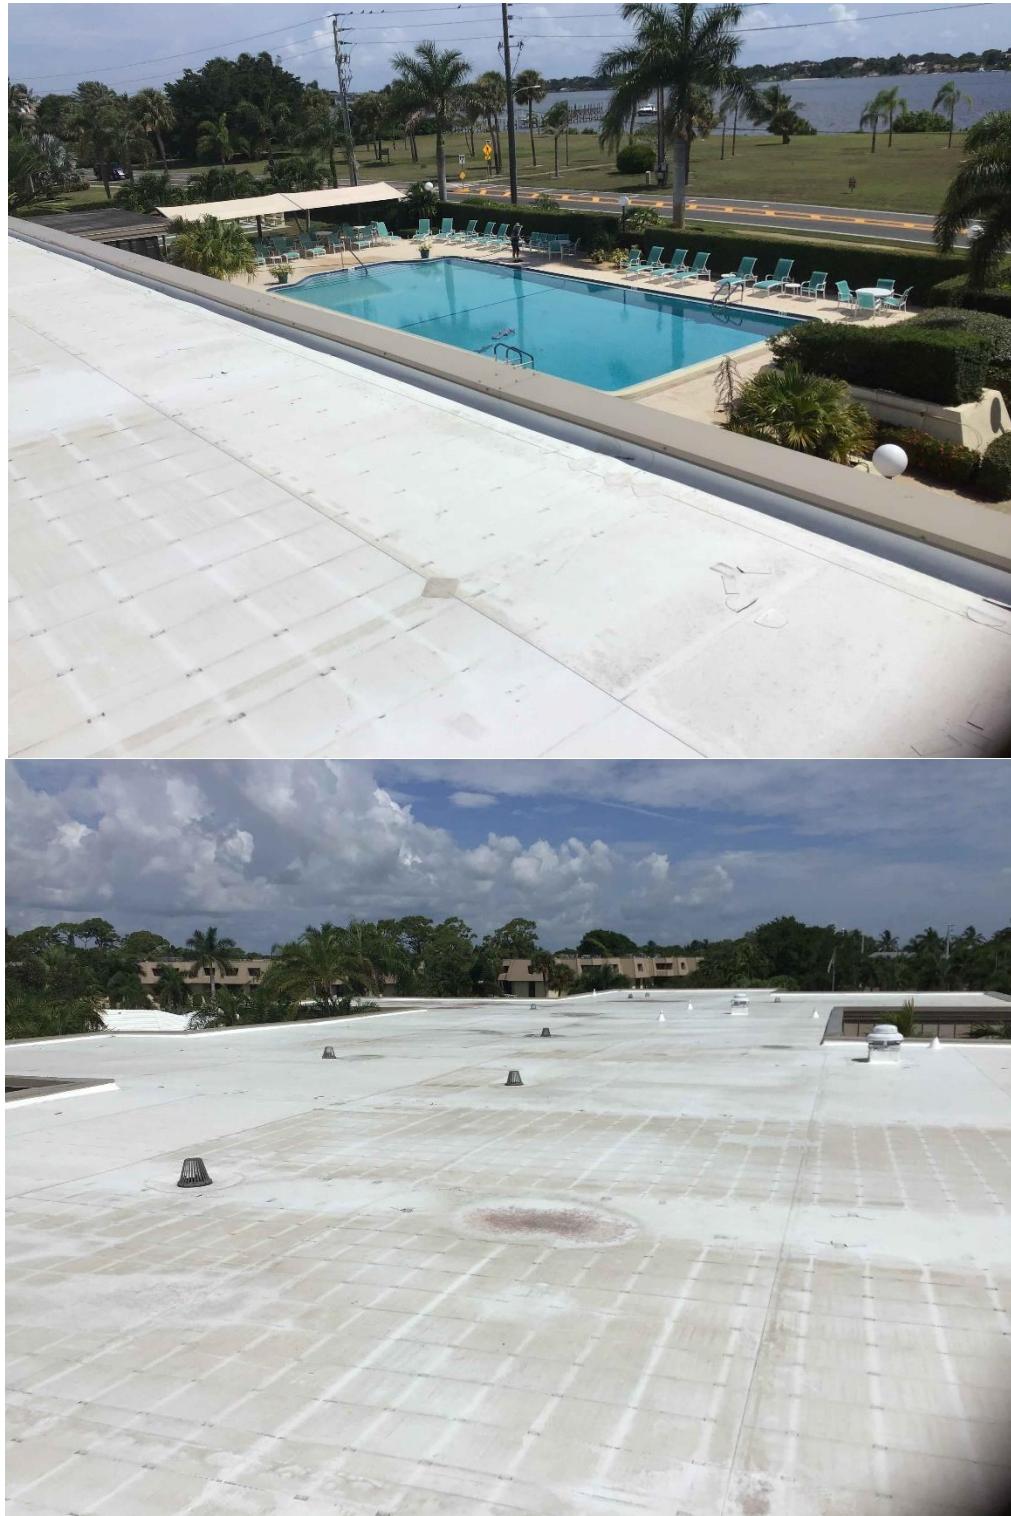
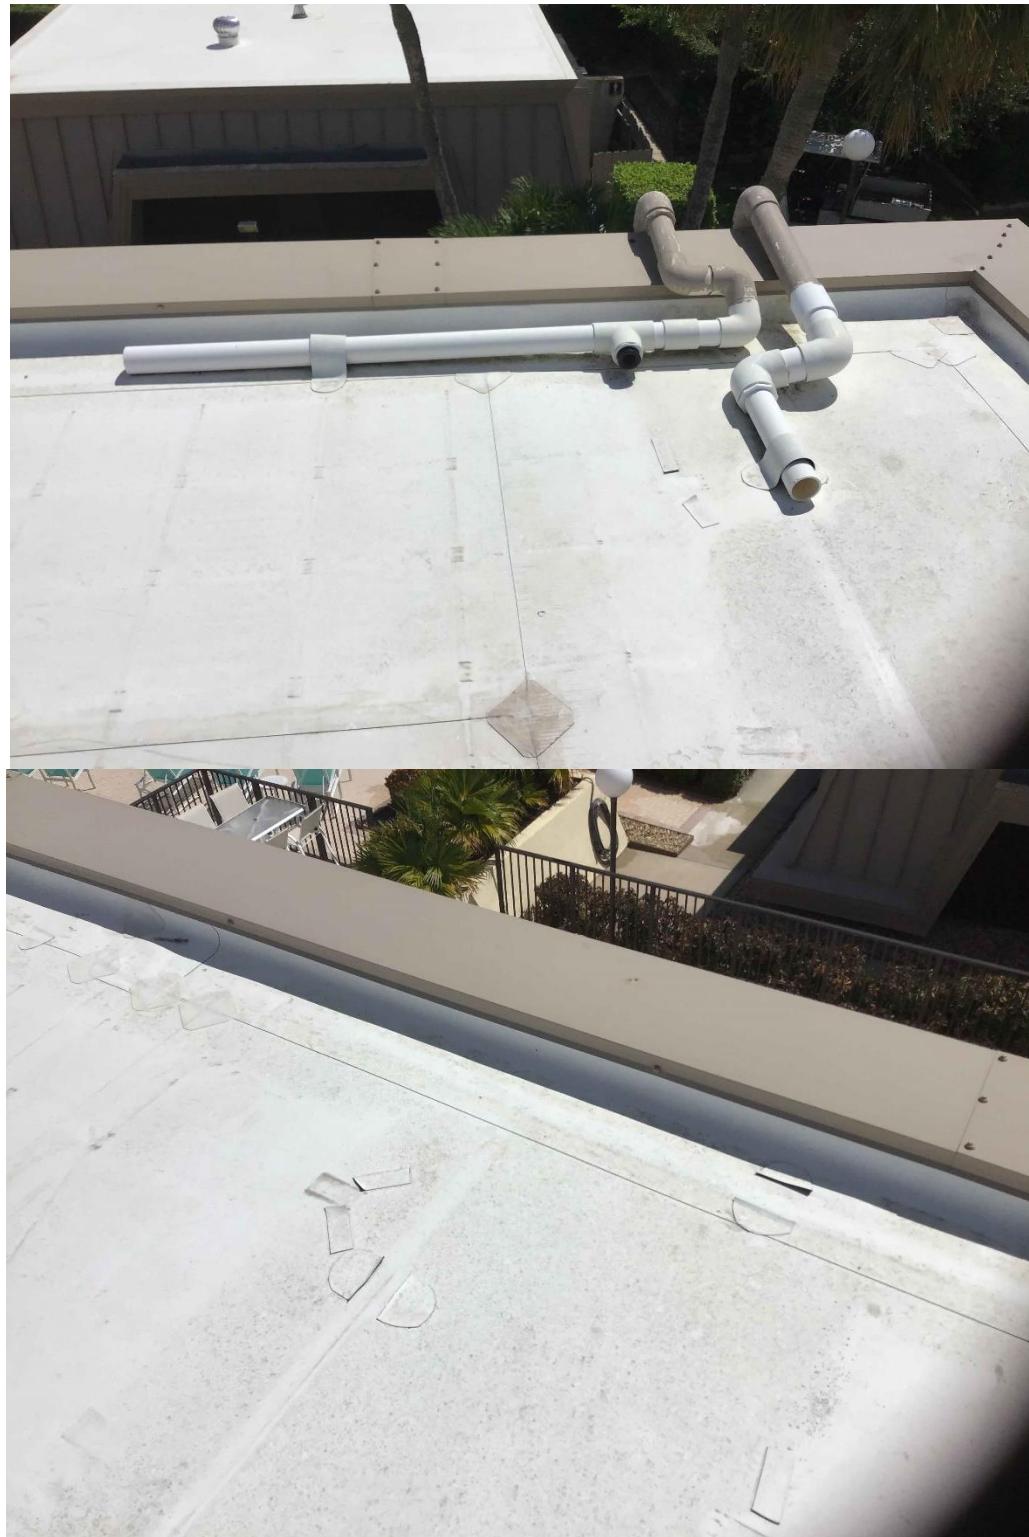
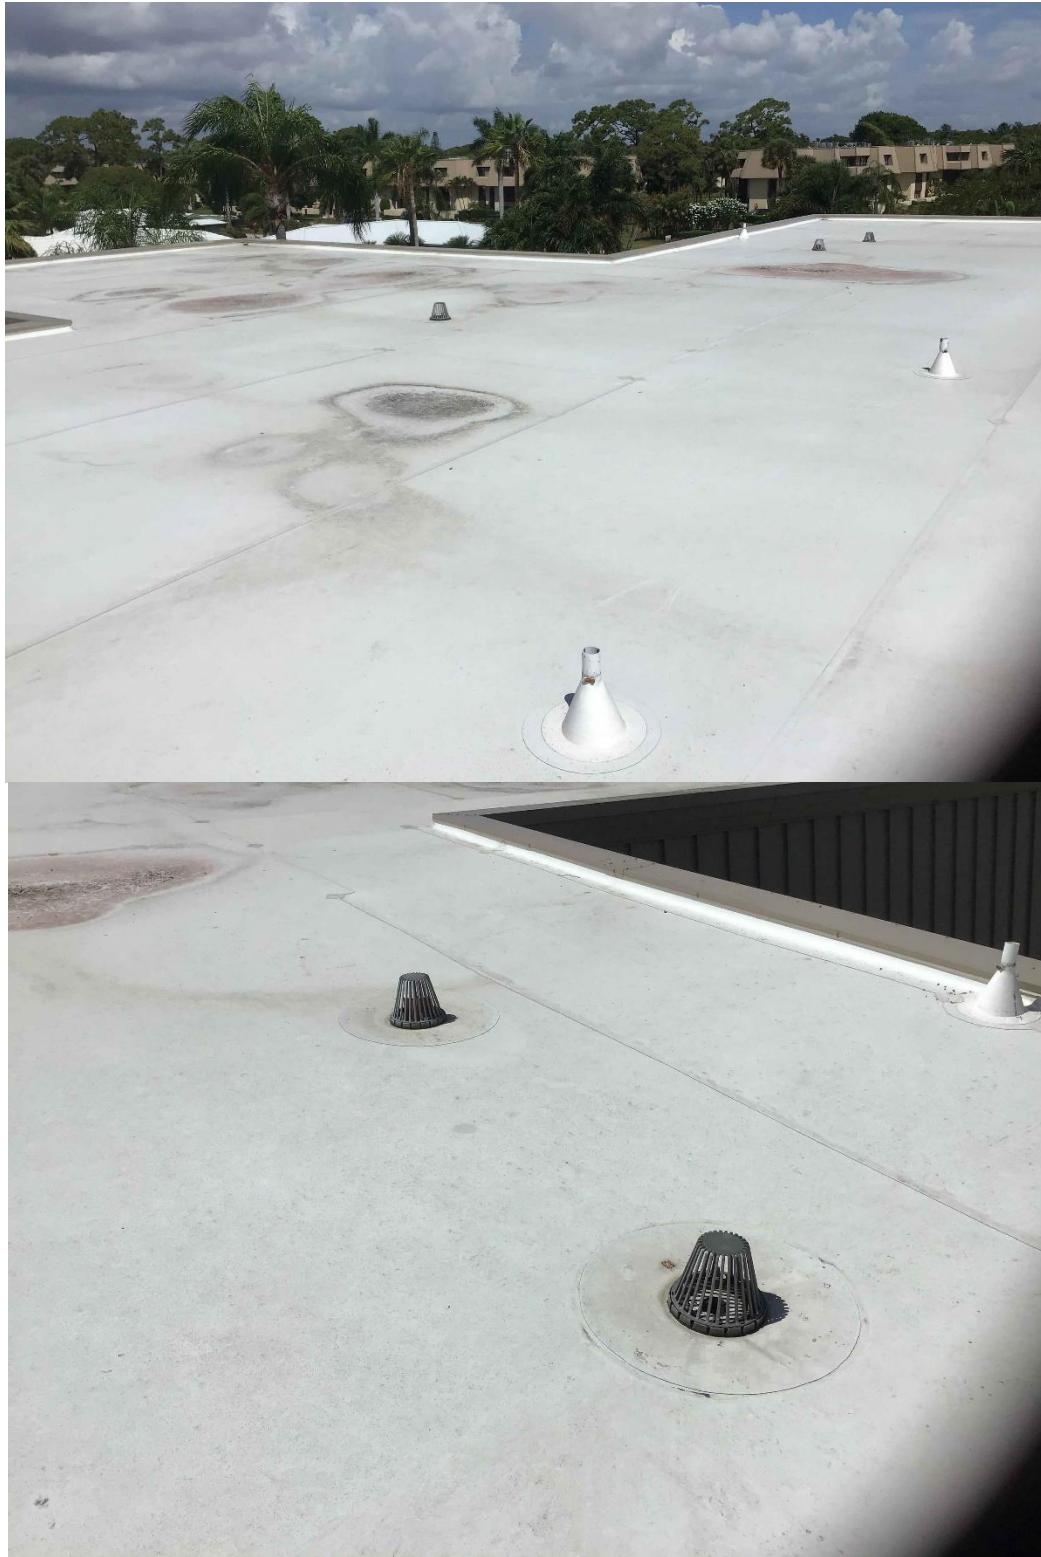
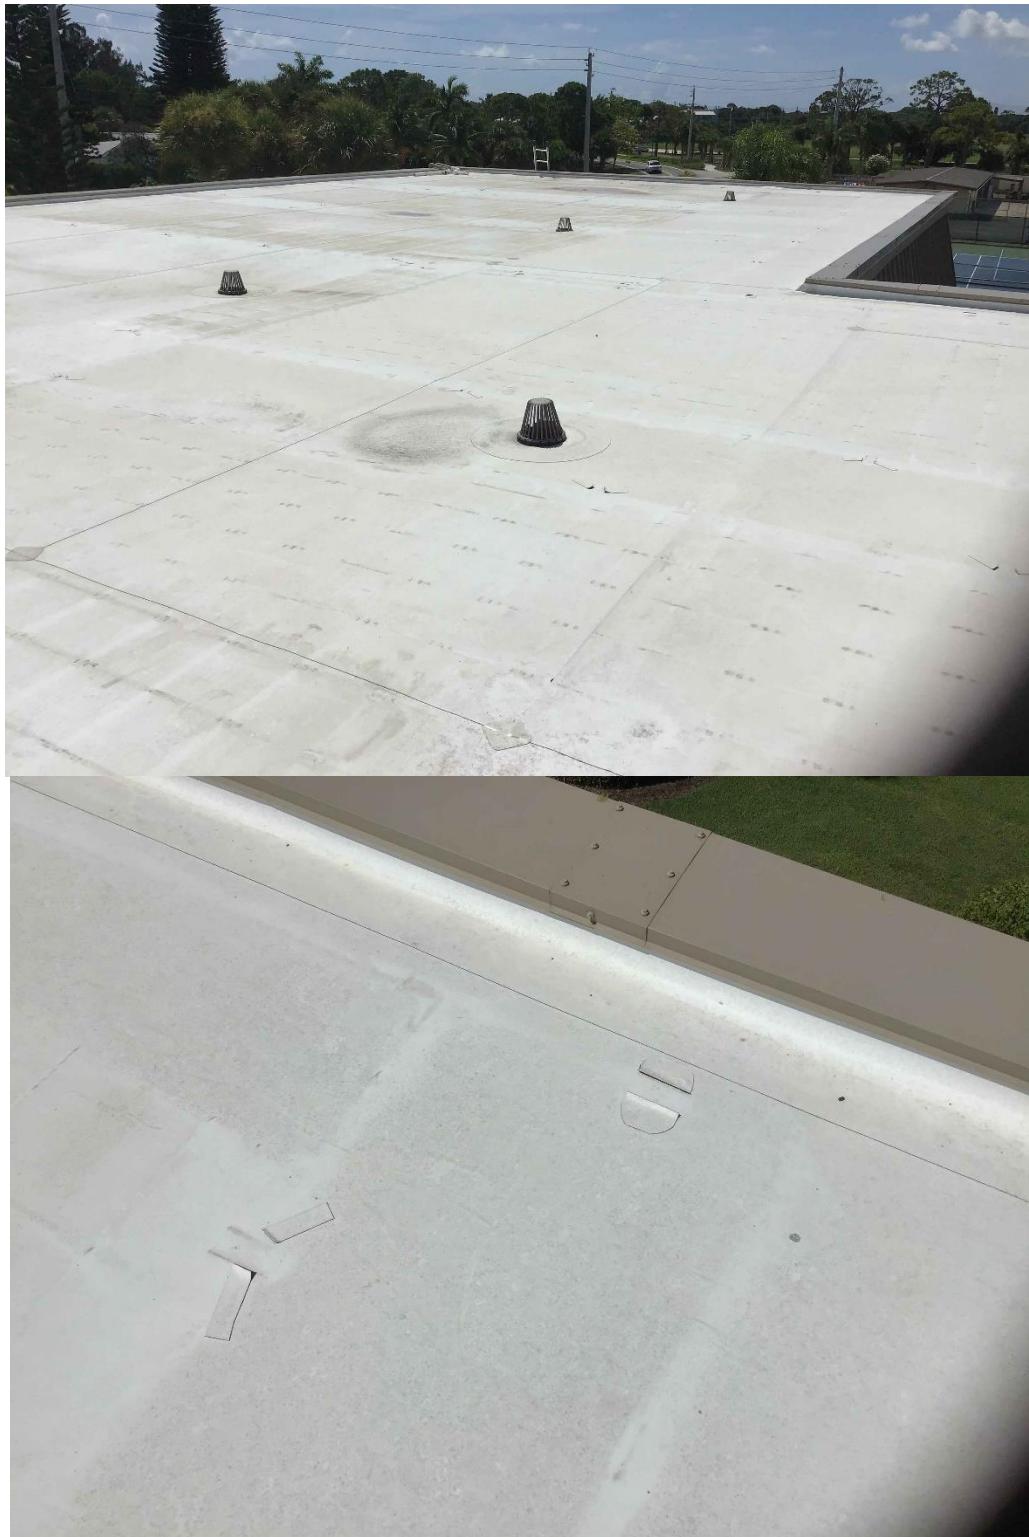
CLUBHOUSE PHOTOS

- Roof installed in 2021 per the Association.
- This roof covering is a membrane with typical wear from weathering conditions.
- Previously Solar heating panels removed from roof.
- Drain/Scuppers are clean and in good working condition.

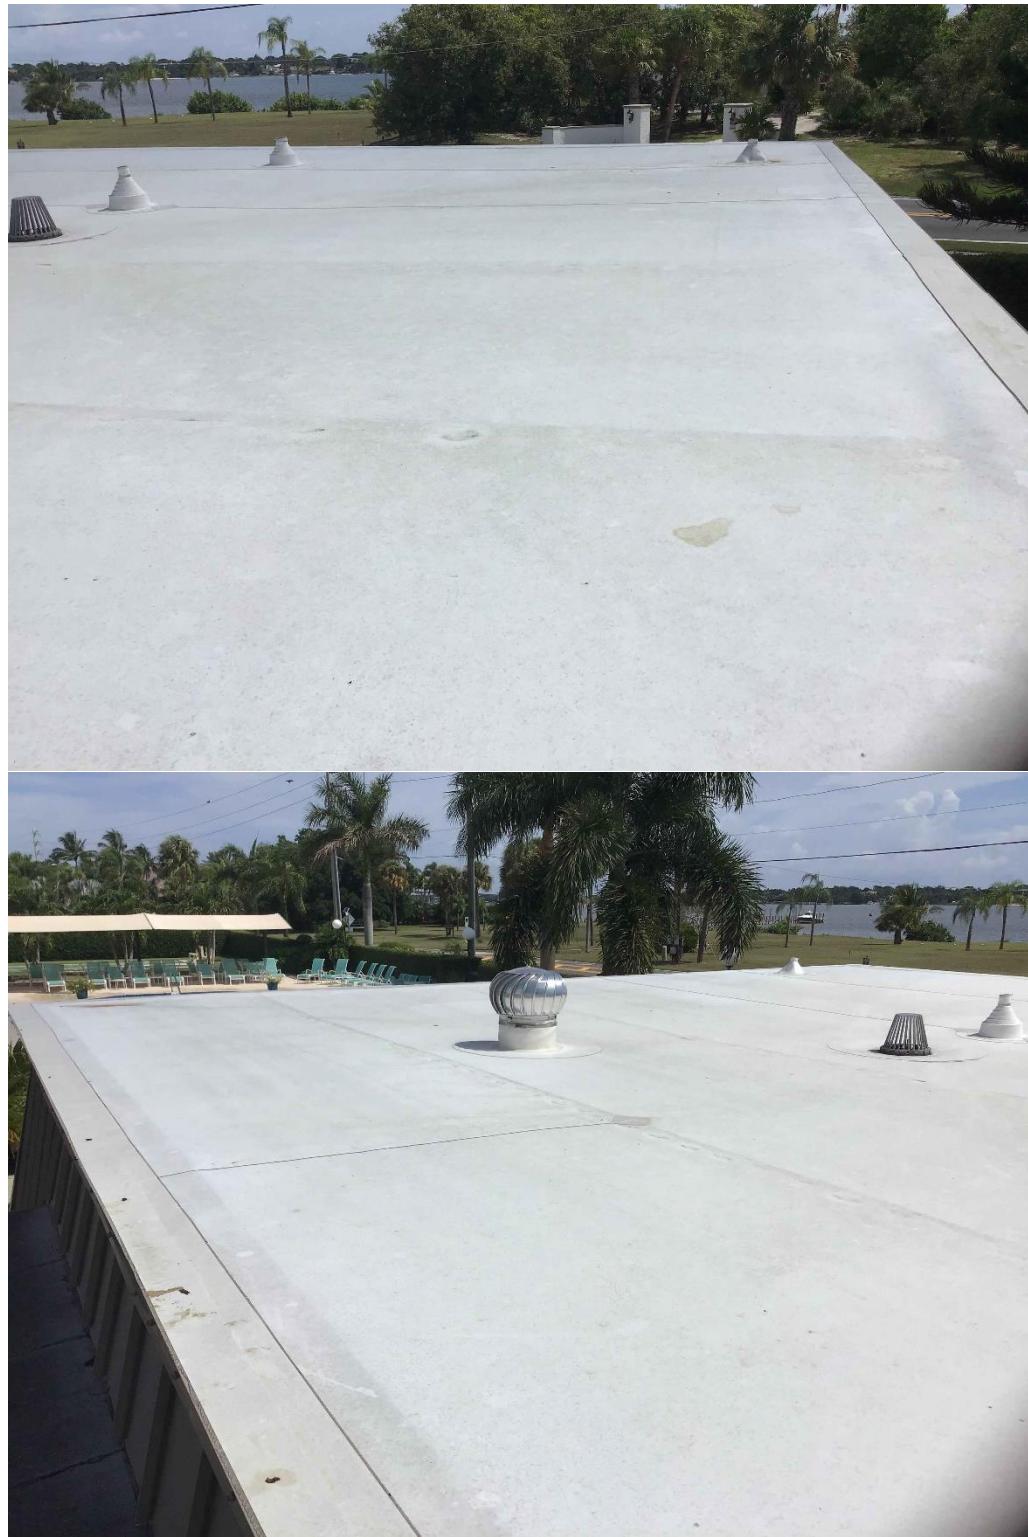
CLUBHOUSE ANCILLARY BUILDING

- Roof installed in 2021 per the Association.
- This roof covering is a membrane with typical wear from weathering conditions.

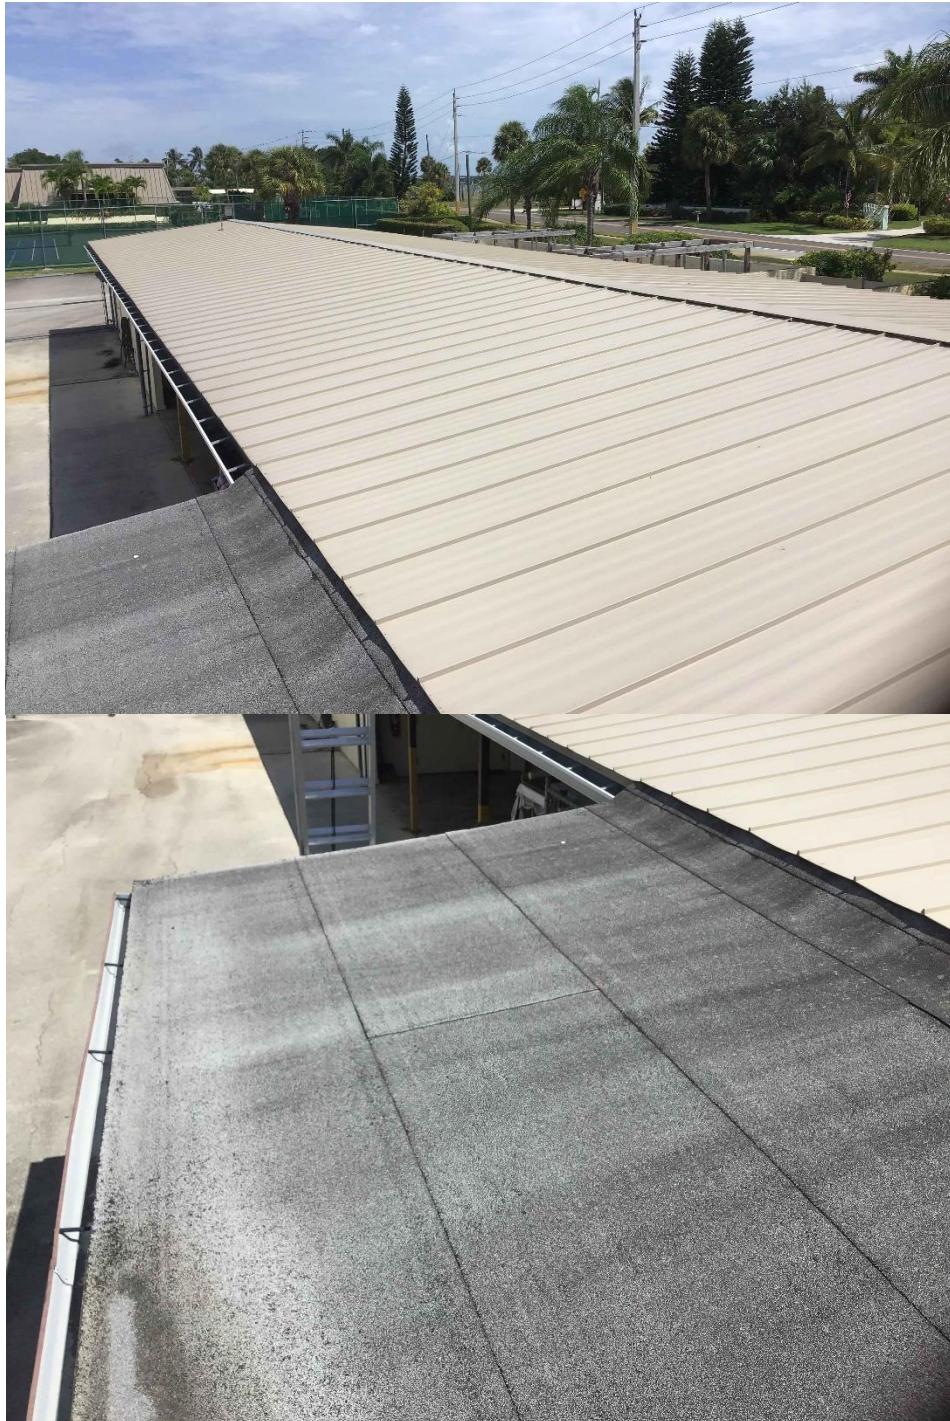
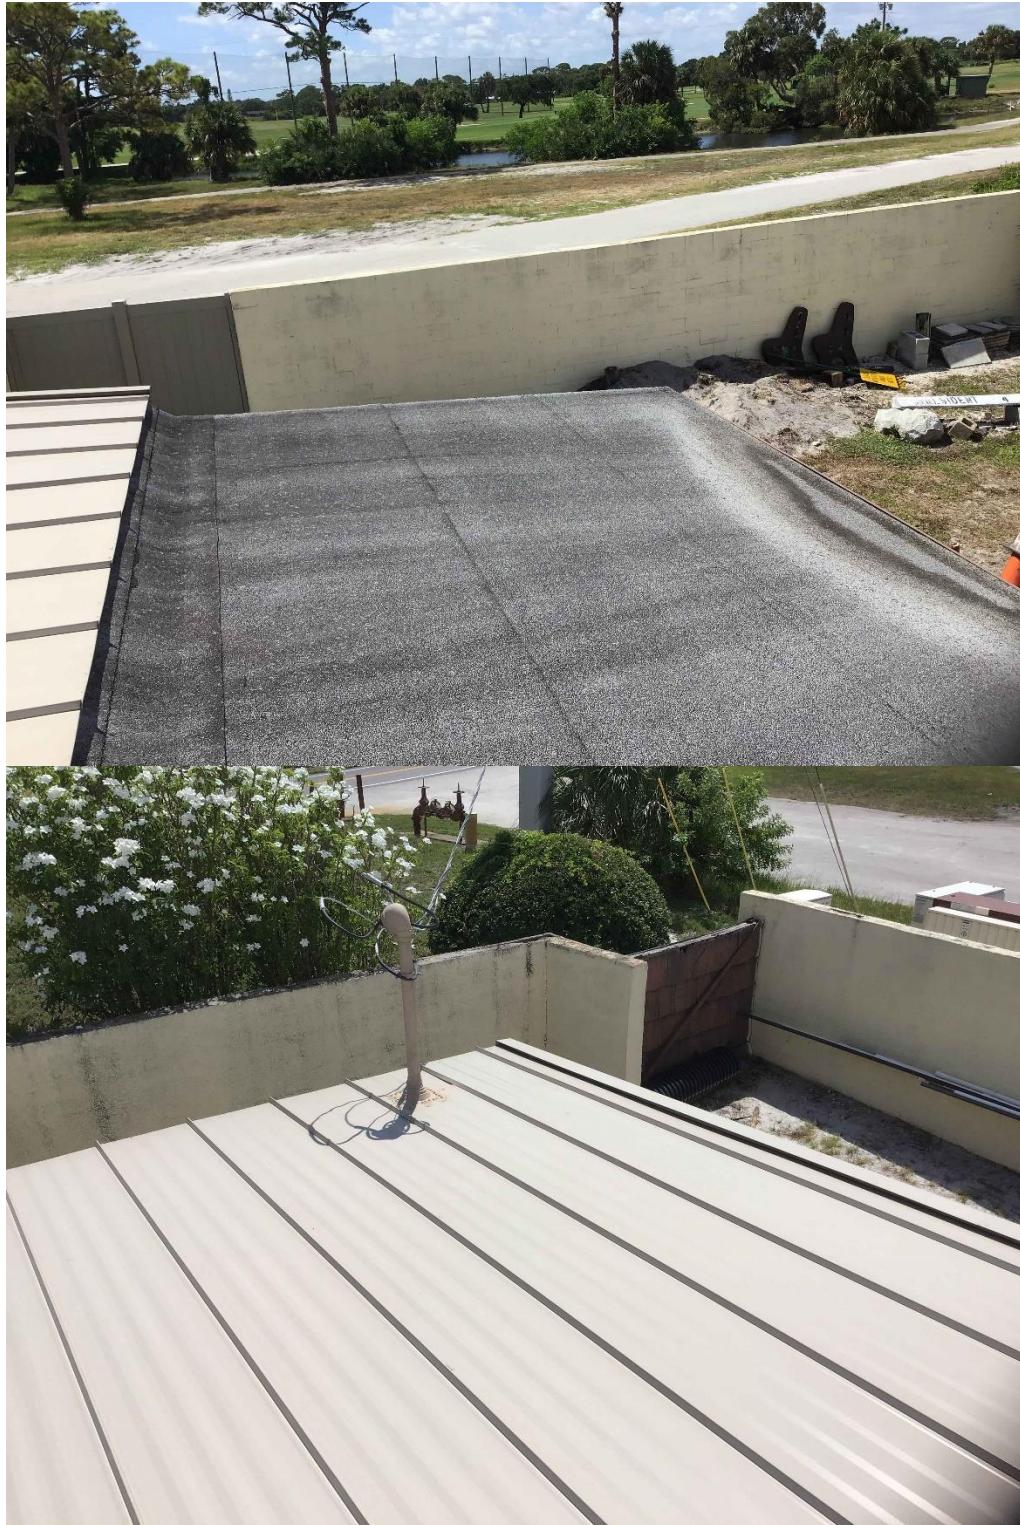
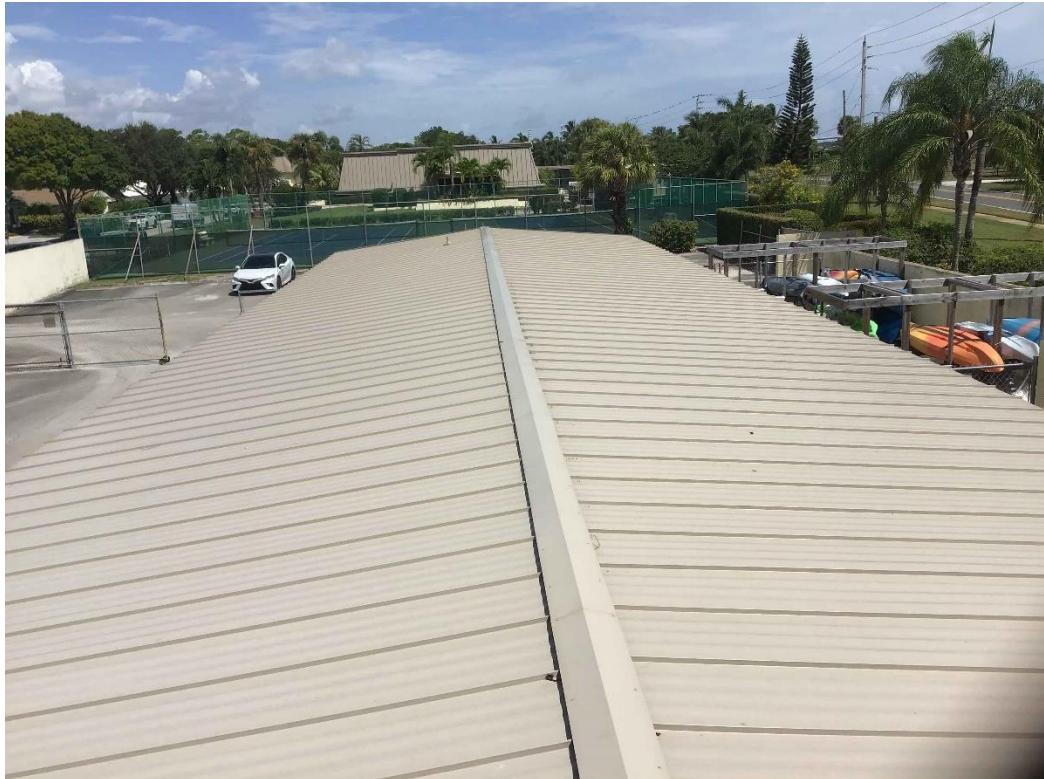
MAINTENANCE BUILDING

- Roof installed in 2018 per the Association
- Roof main covering is a metal raised seam roof. Typical weathering.

- Building has carport type roof cover at side of building which has an asphalt 90lbs gravel tar down application.
