STRUCTURAL INTEGRITY RESERVE STUDY PROPERTY CONDITION ASSESSMENT

Conquistador Condominium - Building 2
1800 St Lucie Boulevard
Stuart, Florida 34996

Project Number 23209116-2

August 23, 2024

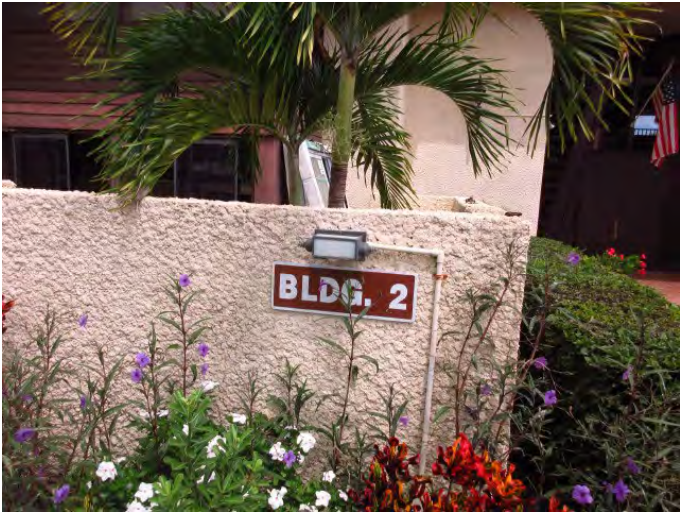
PHOTO 1

PROPERTY IDENTIFICATION SIGN

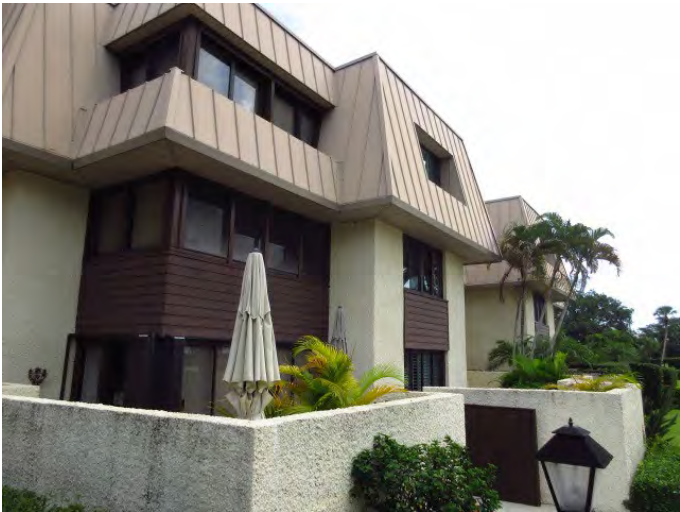
PHOTO 2

GENERAL VIEW OF PROPERTY

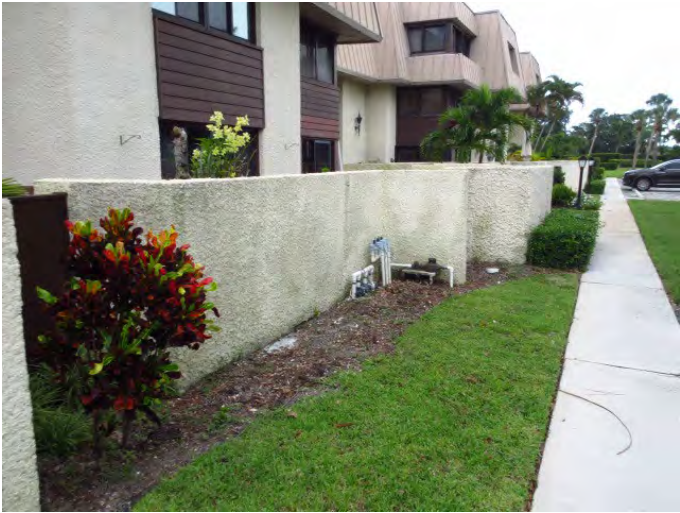
PHOTO 3

GENERAL VIEW OF LANDSCAPING AND SIDEWALK

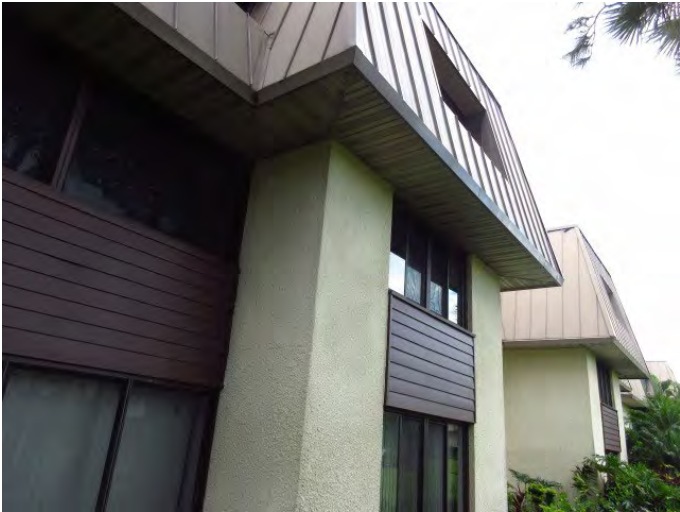
PHOTO 4

GENERAL VIEW OF BUILDING EXTERIOR FINISHES

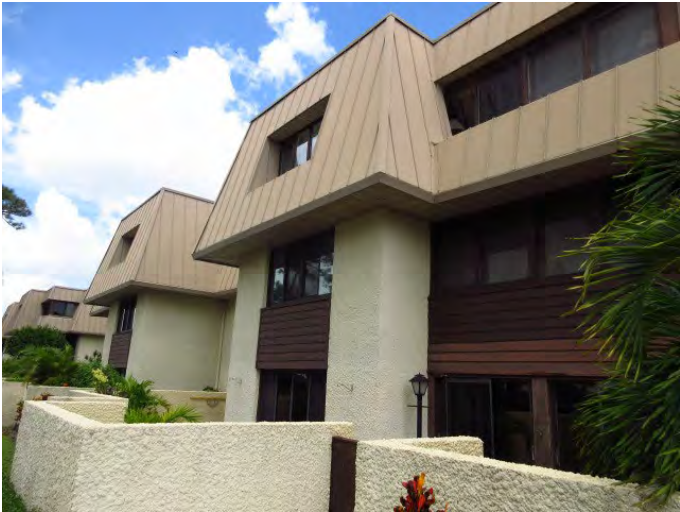
PHOTO 5

GENERAL VIEW OF BUILDING EXTERIOR FINISHES

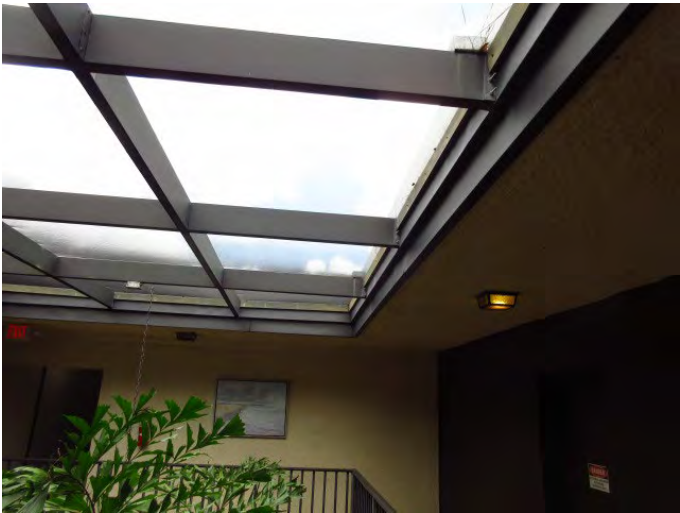
PHOTO 6

Item	Description/Observations/Comments
Skylights	<p>The common area atrium is provided by overhead skylight consisting of an opening on the roof finished with a mesh screen within lightweight aluminum framing.</p> <p>The mesh screen of the skylight was noted to be in good condition. However, the opening is flush with the roof membrane and is not equipped with any type of safety fall protection, creating a potential safety hazard. We recommend installing a safety railing barrier around the perimeter of the opening. Funds for this work have been allocated in the Immediate Repairs Cost Estimate Table.</p>
Patios / Balconies	<p>The patios generally include concrete slabs, with various finishes. The balconies are supported by the building structural system and include concrete decking, with aluminum railing. Patios and balconies are provided with mesh screens creating lanai features.</p> <p>The patio and balconies are the responsibility of the individual condominium unit owner.</p>

VIEW OF SKYLIGHT

Item No.	Item Description	Quantity	Unit	Cost	Totals	Comments
1	Mansard repair	1	LS	\$2,000.00	\$2,000.00	Repair localized damaged and corroded panels
2	Skylight safety railing	80	LF	\$150.00	\$12,000.00	Install safety railing around skylight on roof
					Subtotal	
				Total Immediate Repairs	\$14,000.00	
				Cost Per Unit	\$583.33

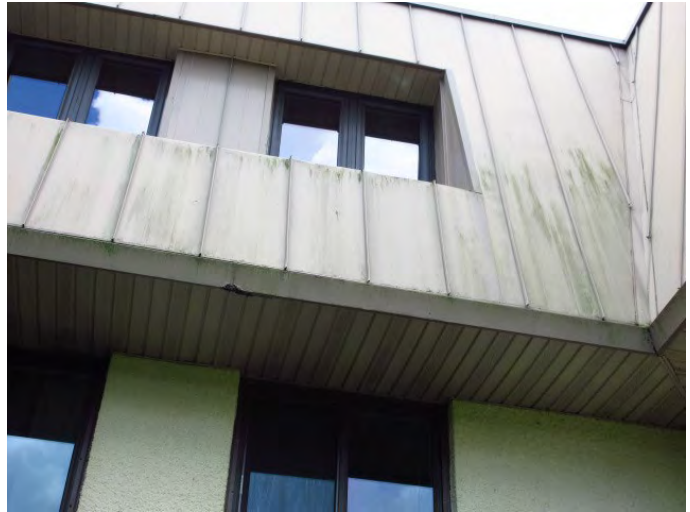
PHOTO 7

GENERAL VIEW OF MANSARD

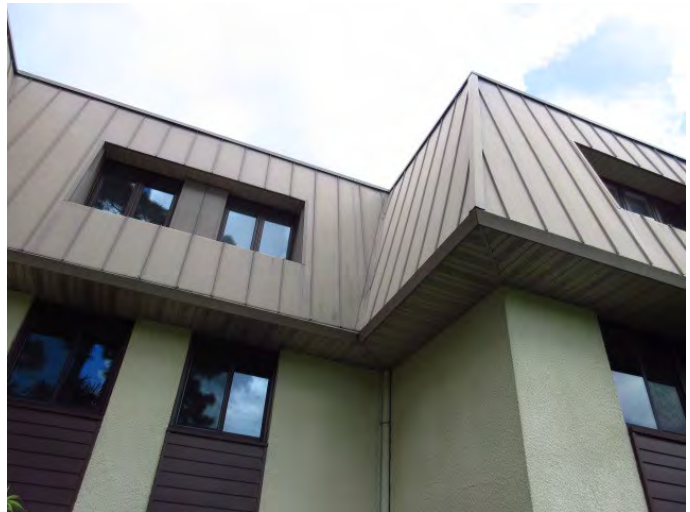
PHOTO 8

GENERAL VIEW OF MANSARD

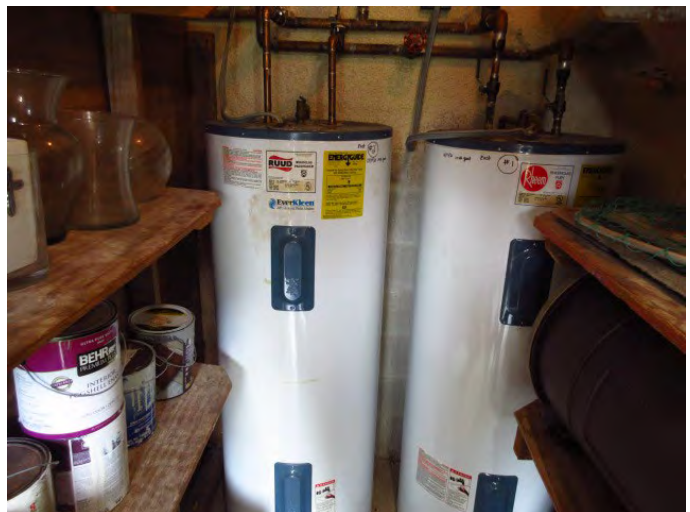
PHOTO 9

VIEW OF WATER HEATERS

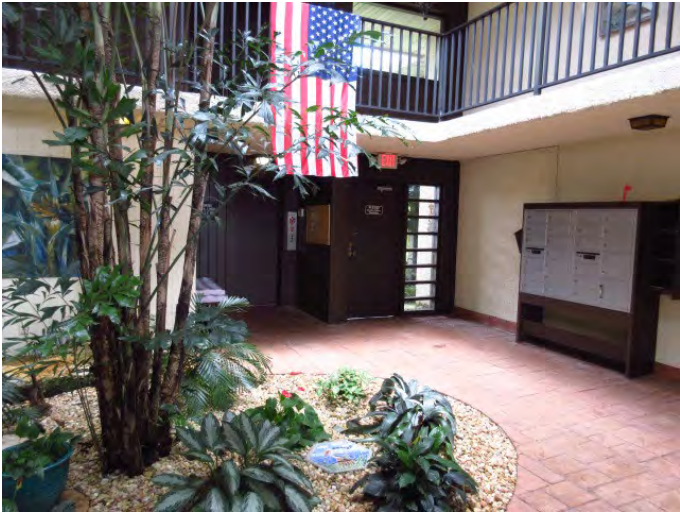
PHOTO 10

GENERAL VIEW OF MAIN ENTRANCE ATRIUM

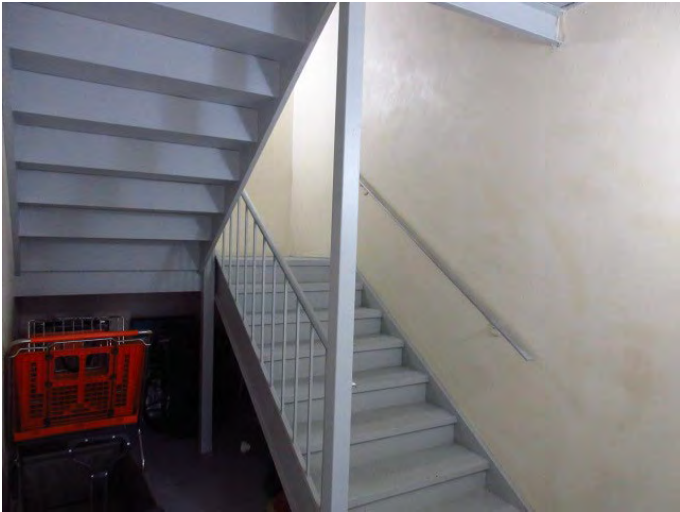
PHOTO 11

GENERAL VIEW OF INTERIOR STAIRS

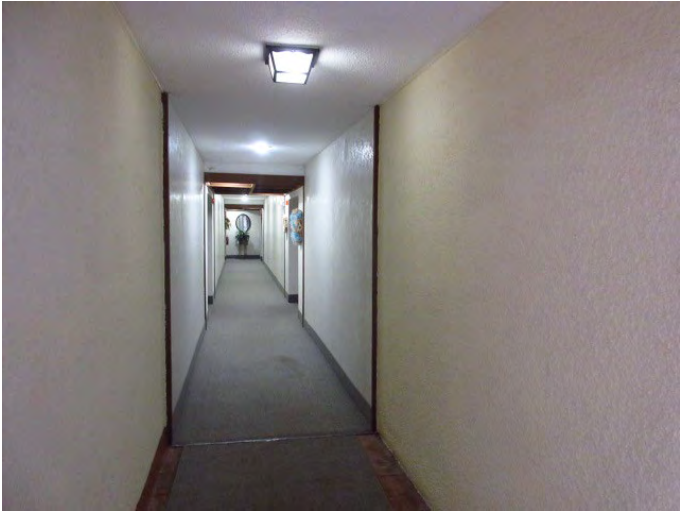
PHOTO 12

Item	Description/Observations/Comments
Tenant Spaces	Areas within the interior of the resident units are the responsibility of the individual condominium unit owner.
Common Areas	<p>The common area finishes consist of tile flooring, and painted gypsum-board walls and ceiling.</p> <p>The interior common areas appeared to be in good condition. Funds for replacement of common area finishes have been allocated throughout the reserve period, adopting the straight-line accounting method to ensure the availability of funds at the end of the element's EUL, beyond the evaluation period of this assessment.</p>

VIEW OF COMMON AREA HALLWAY
