STRUCTURAL INTEGRITY RESERVE STUDY PROPERTY CONDITION ASSESSMENT

Conquistador Condominium - Building 5
1800 St Lucie Boulevard
Stuart, Florida 34996

Project Number 23209116-5

August 23, 2024

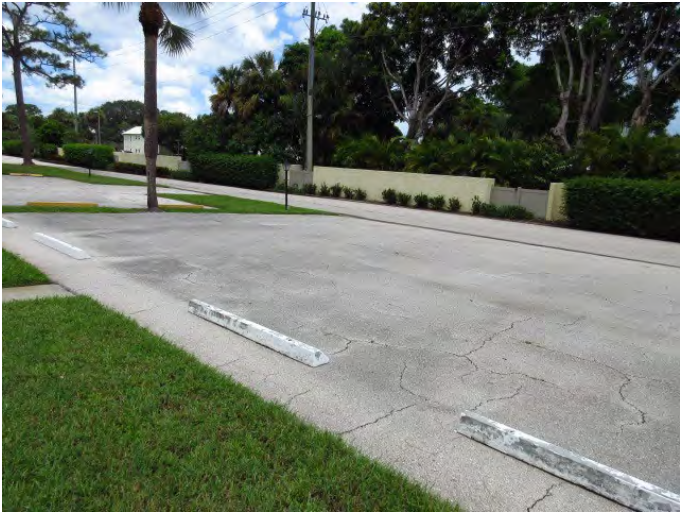
PHOTO 3

Parking/Paving	<p>The interior drives and parking surfaces are paved with asphalt. Parking is typically provided for approximately 37 vehicles.</p> <p>The parking and driveway areas were noted to be in fair condition with areas of cracking noted requiring repair / crack-sealing. Funds have been allocated in the Immediate Repairs Cost Estimate Table.</p> <p>To maximize the pavement life, periodic crack-sealing, sealcoating and striping are recommended during the evaluation period. In addition, based on the Expected Useful Life (EUL) of 25 years for asphalt pavement, resurfacing should be anticipated during the evaluation period. Funds have been spread throughout Replacement Reserves Cost Estimate Table, adopting the straight-line accounting method to ensure the availability of funds at the end of the replaced element's EUL, beyond the evaluation period of this assessment.</p>
Sidewalks	<p>Property sidewalks consist of cast-in-place concrete.</p> <p>The sidewalks appeared to be in good condition with minor cracking noted. Funds for periodic repair / replacement have been allocated throughout the reserve period, adopting the straight-line accounting method to ensure the availability of funds at the end of the element's EUL, beyond the evaluation period of this assessment.</p>

GENERAL VIEW OF PARKING AND PAVEMENT

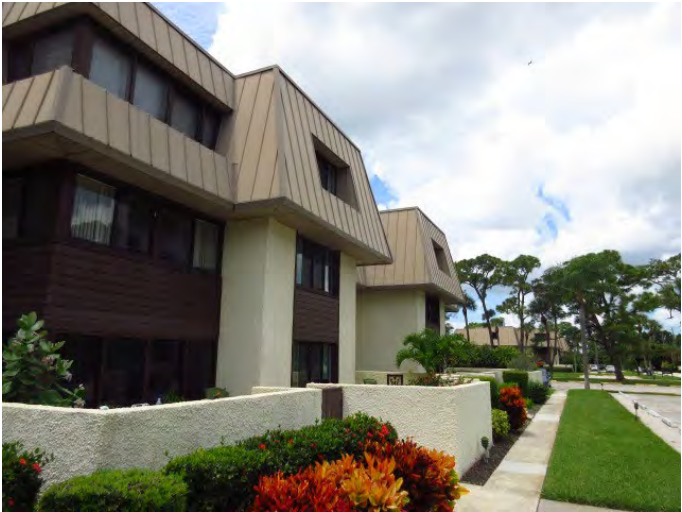
PHOTO 4

GENERAL VIEW OF BUILDING EXTERIOR FINISHES

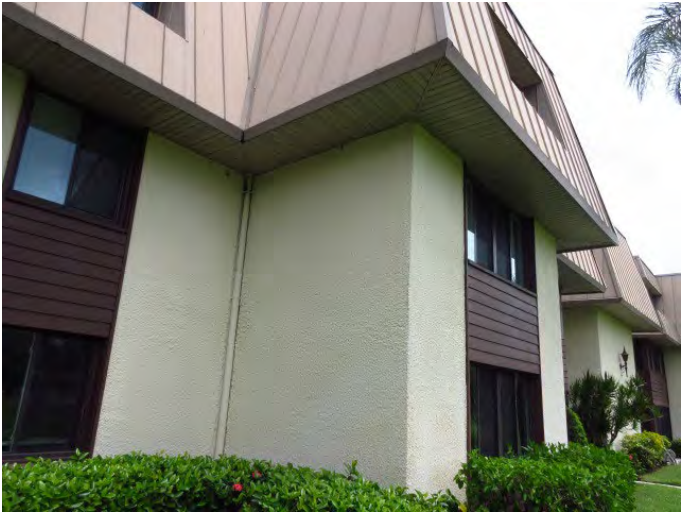
PHOTO 5

GENERAL VIEW OF BUILDING EXTERIOR FINISHES

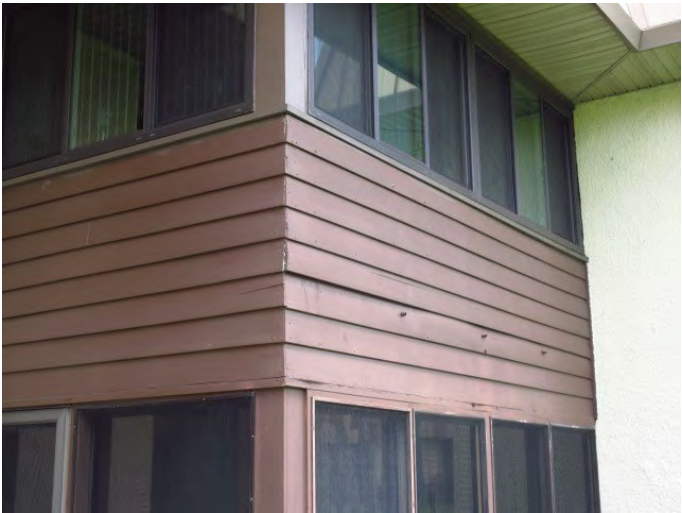
PHOTO 6

VIEW OF BUILDING EXTERIOR FINISHES

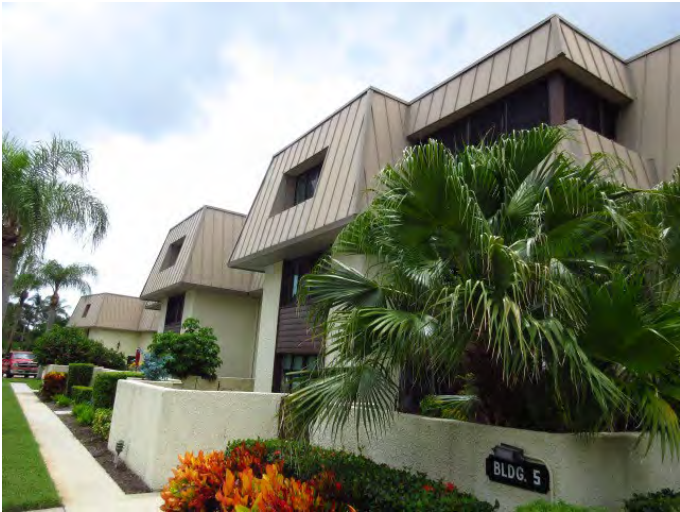
PHOTO 7

GENERAL VIEW OF MANSARD

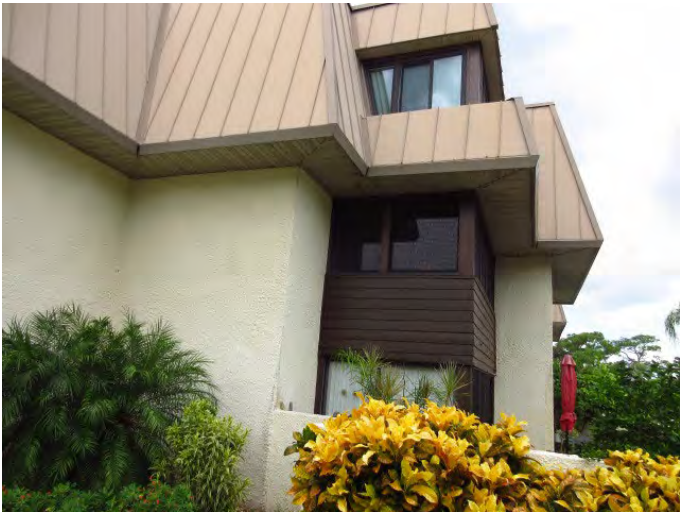
PHOTO 8

GENERAL VIEW OF MANSARD

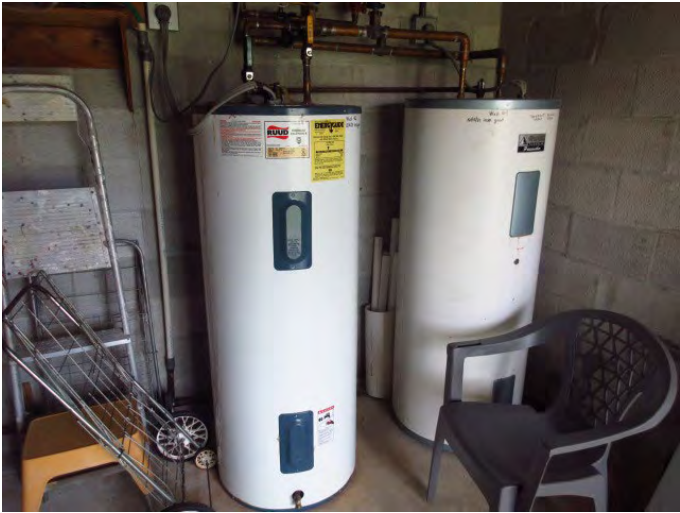
PHOTO 9

VIEW OF WATER HEATERS

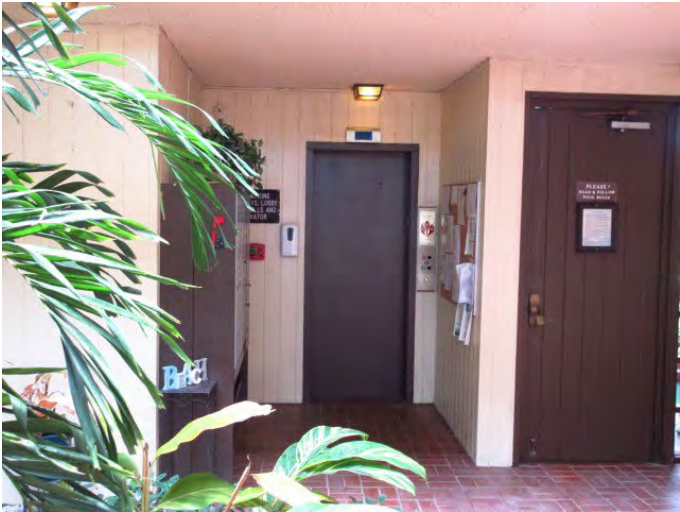
PHOTO 10

GENERAL VIEW OF ELEVATOR LOBBY

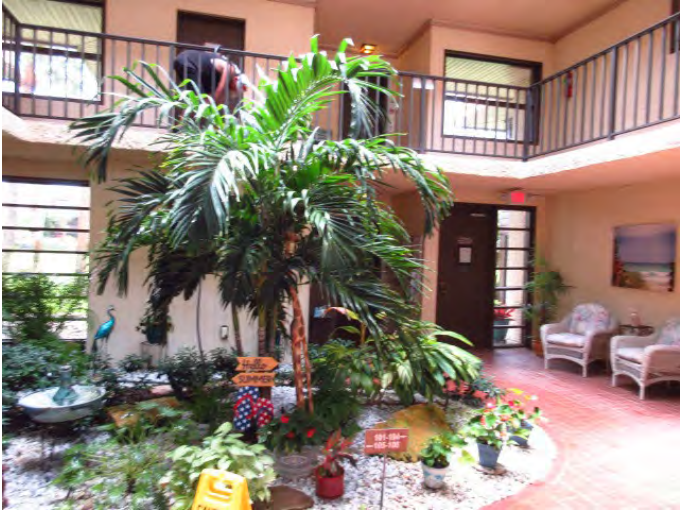
PHOTO 11

Item	Description/Observations/Comments
Skylights	<p>The common area atrium is provided by overhead skylight consisting of an opening on the roof finished with a mesh screen within lightweight aluminum framing.</p> <p>The mesh screen of the skylight was noted to be in good condition. However, the opening is flush with the roof membrane and is not equipped with any type of safety fall protection, creating a potential safety hazard. We recommend installing a safety railing barrier around the perimeter of the opening. Funds for this work have been allocated in the Immediate Repairs Cost Estimate Table.</p>
Patios / Balconies	<p>The patios generally include concrete slabs, with various finishes. The balconies are supported by the building structural system and include concrete decking, with aluminum railing. Patios and balconies are provided with mesh screens creating lanai features.</p> <p>The patio and balconies are the responsibility of the individual condominium unit owner.</p>

VIEW OF ATRIUM

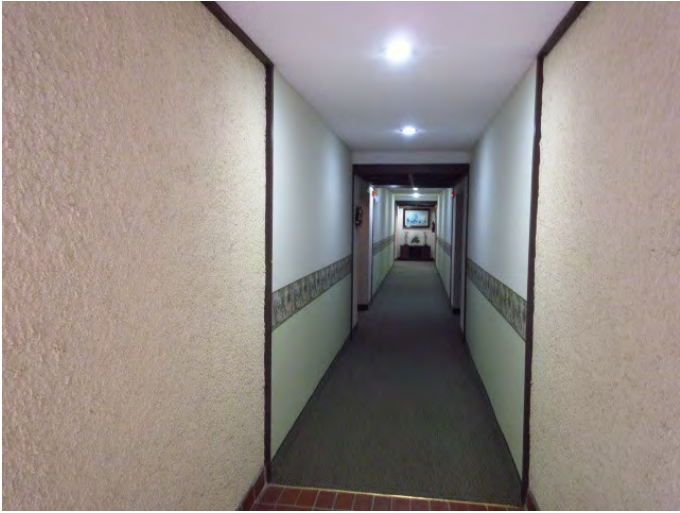
PHOTO 12

VIEW OF COMMON AREA HALLWAY
