TRADITIONAL RESERVE STUDY STRUCTURAL INTEGRITY RESERVE STUDY

Conquistador Condominium - Building 8
1800 St Lucie Boulevard
Stuart, Florida 34996

Project Number 23209116-8

August 23, 2024

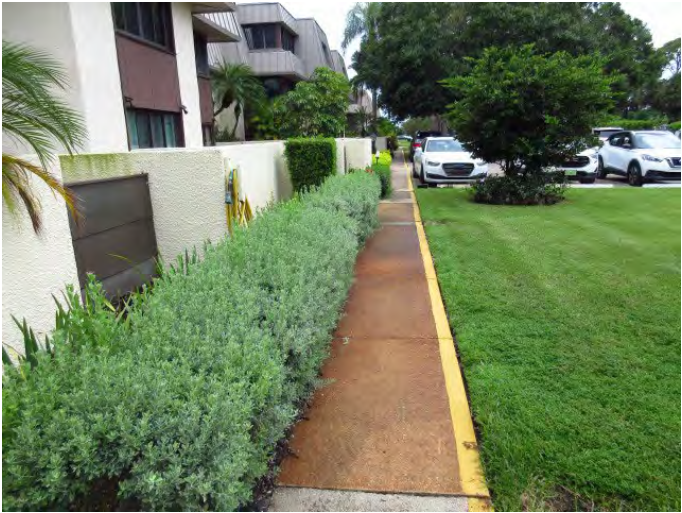
PHOTO 3

Sidewalks	<p>Property sidewalks consist of cast-in-place concrete.</p> <p>The sidewalks appeared to be in good condition with minor cracking noted requiring only routine maintenance over the evaluation period.</p>
Site Amenities	<p>There are common area amenities identified as LRA-2 with maintenance responsibilities funded by condo owners within Buildings 6 through 10. They include the swimming pool, equipment, decking and fence, gazebos, and water well.</p> <p>An annual budget to maintain these elements has been spread throughout the Replacement Reserves Cost Estimate Table.</p>

GENERAL VIEW OF LANDSCAPING AND SIDEWALK

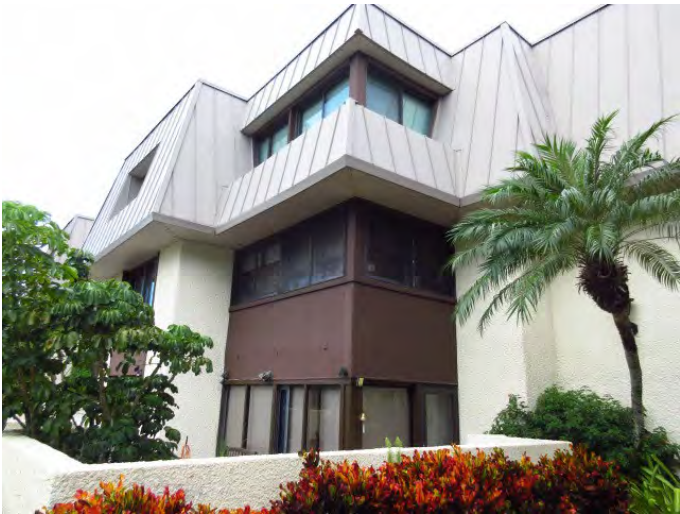
PHOTO 4

GENERAL VIEW OF BUILDING EXTERIOR FINISHES

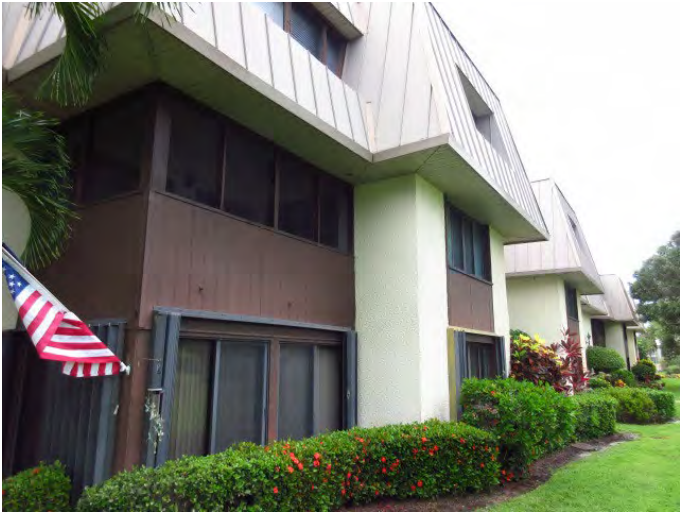
PHOTO 5

GENERAL VIEW OF BUILDING EXTERIOR FINISHES

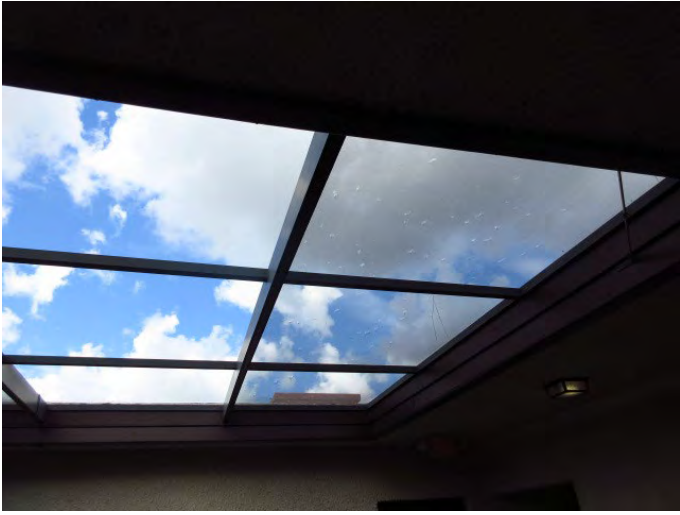
PHOTO 6

Item	Description/Observations/Comments
Skylights	<p>The common area atrium is provided by overhead skylight consisting of an opening on the roof finished with a mesh screen within lightweight aluminum framing.</p> <p>The mesh screen of the skylight was noted to be in good condition. However, the opening is flush with the roof membrane and is not equipped with any type of safety fall protection, creating a potential safety hazard. We recommend installing a safety railing barrier around the perimeter of the opening. Funds for this work have been allocated in the Immediate Repairs Cost Estimate Table.</p>
Patios / Balconies	<p>The patios generally include concrete slabs, with various finishes. The balconies are supported by the building structural system and include concrete decking, with aluminum railing. Patios and balconies are provided with mesh screens creating lanai features.</p> <p>The patio and balconies are the responsibility of the individual condominium unit owner.</p>

VIEW OF SKYLIGHT

Item No.	Item Description	Quantity	Unit	Cost	Totals	Existing Balance	Remaining Funds	Comments
1	Skylight safety railing	80	LF	\$150.00	\$12,000.00			Install safety railing around skylight on roof
					Subtotal	\$113,002.03	\$101,002.03	
					Total Immediate Repairs	\$12,000.00		
					Cost Per Unit	\$500.00

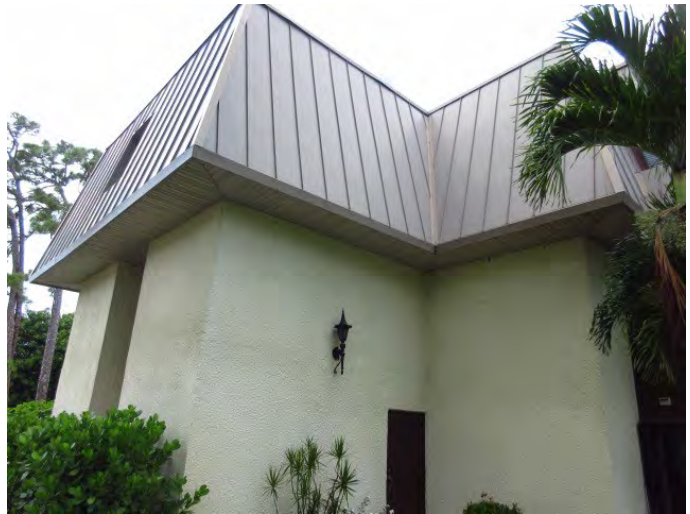
PHOTO 7

GENERAL VIEW OF MANSARD

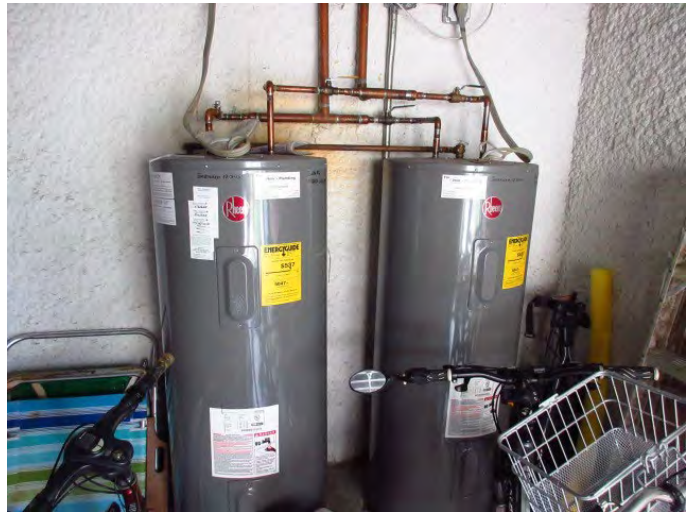
PHOTO 8

GENERAL VIEW OF DOMESTIC WATER HEATERS

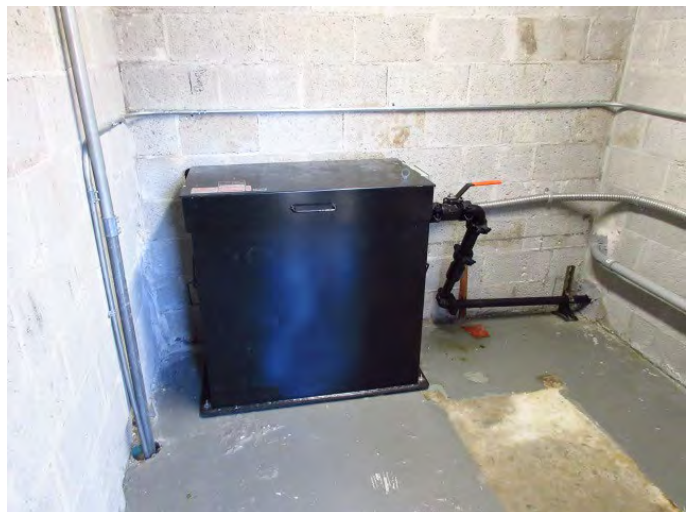
PHOTO 9

Item	Description/Observations/Comments
Elevators	<p>The building is equipped with one hydraulic elevator, rated at 2,500 pounds of load capacity, providing access to all floors.</p> <p>The elevator was noted to be in generally good operating condition and reportedly serviced regularly by an elevator service contractor.</p> <p>The elevator was reportedly modernized in 2023. Elevator controls typically have an EUL of 25 years and should not be anticipated to require upgrade / modernization during the evaluation period. However, funds for component and control upgrades have been spread throughout the Replacement Reserves Cost Estimate Table, adopting the straight-line accounting method to ensure the availability of funds at the end of the replaced element's EUL beyond the evaluation period of this assessment.</p>
Escalators	<p>There are no escalators at the Property.</p>
Stairs	<p>The stairs are poured concrete with closed risers and aluminum railing.</p> <p>The stairs appeared to be in generally good condition, with no significant deficiencies noted, requiring routine maintenance during the evaluation period.</p>

VIEW OF ELEVATOR EQUIPMENT

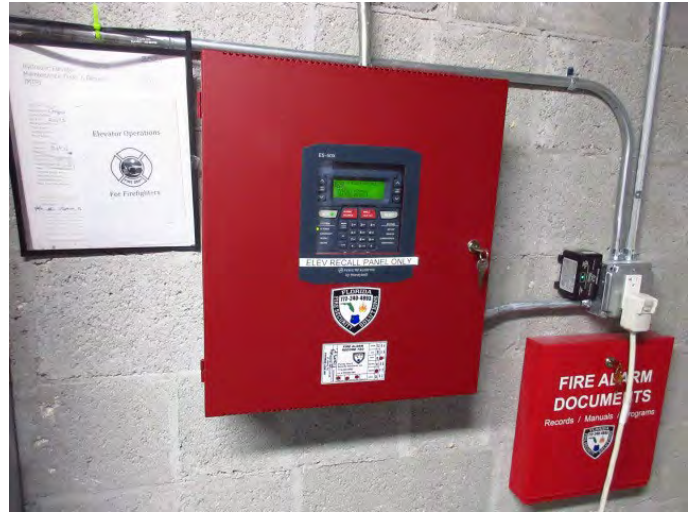
PHOTO 10

Item	Description/Observations/Comments
Fire Protection	<p>ABC-type portable fire extinguishers are in the common areas.</p> <p>The building is equipped with a central fire alarm system that monitors the pull stations. The panel also sounds the alarm and automatically notifies the monitoring service or the fire department in the event of trouble.</p> <p>The fire extinguishers were noted to be in general condition requiring routine maintenance over the evaluation period.</p> <p>The central alarm panel was replaced in 2023. Alarm panels typically have an EUL of 25 years. As such, replacement should not be anticipated during the evaluation period. However, funds have been spread throughout the Replacement Reserves Cost Estimate Table, adopting the straight-line accounting method to ensure the availability of funds at the end of the replaced element's EUL, beyond the evaluation period of this assessment.</p> <p>Fire protection and life safety systems within the dwelling units are reported to be the responsibility of the respective condominium unit owner to maintain and replace.</p>

VIEW OF CENTRAL ALARM PANEL
