Dock Inspection Report

**Mrs. Bonnie Guenther
Conquistador Homeowner's Association**

Property Address:
1800 SE St Lucie Blvd
Stuart FL 34996

July 17th, 2021

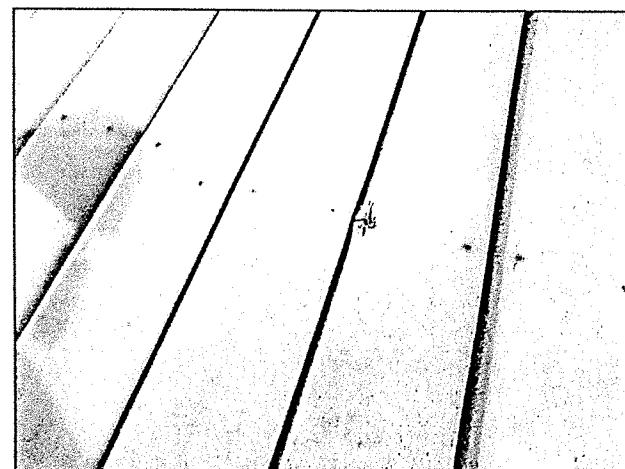
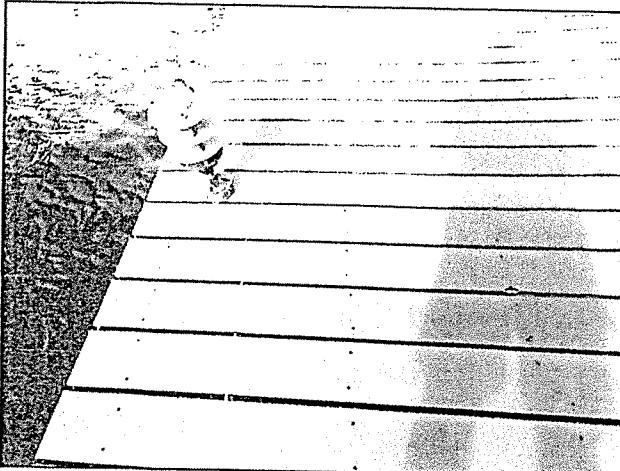
The deck exhibited minor signs of deterioration with some boards beginning to crack around some of the screws.

Some boards are not properly installed and not leveled with the rest of the deck. This is a trip hazard which should be corrected to prevent trip and fall accidents.

Also, there are several screw heads sticking out of the deck boards. Several screws are corroded as they stick out of the boards. This also represents a risk of injury and possible trip hazard.

Recommend repair or replacement of all damaged deck boards, re-placement of corroded screws, and re-tightening of all deck boards.

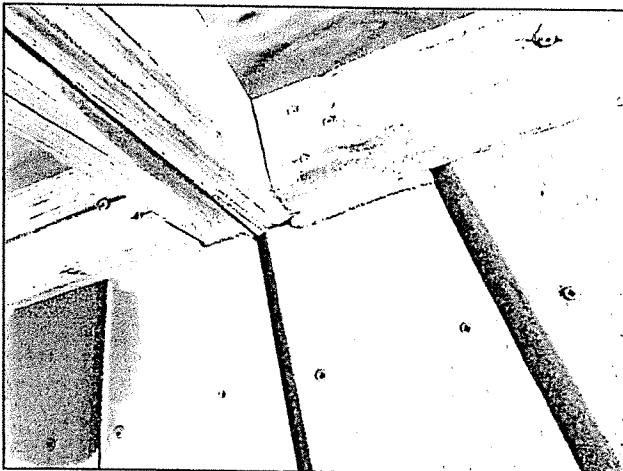
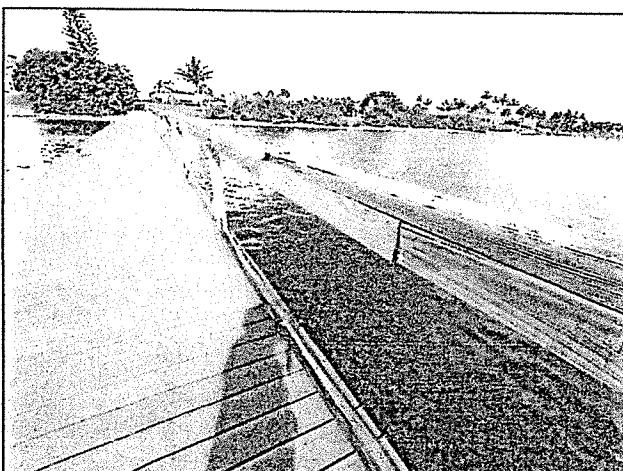
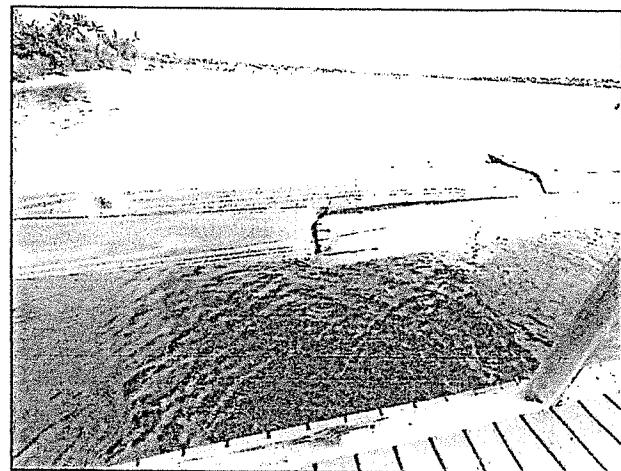
There is a wood deck rail on the entire left extension of the dock. The wood is very old and exhibited moderate levels of deterioration due to exposure to weather and sun.

Inspector found that several deck railing joints were separating or splitting. This represents a risk as people can get insured by corroded screws and splinters.

Inspector also found that a large portion of the railing was loose. The area is represented by the first 160 lineal feet of deck railing.

Recommend repair or replacement of all deck railings where the joints are separating, torn, or has corroded screws. Recommend repair or replacement of the section of railing that is loose. Recommend application of deck painting once every couple of years to extend the life of the wood railings.

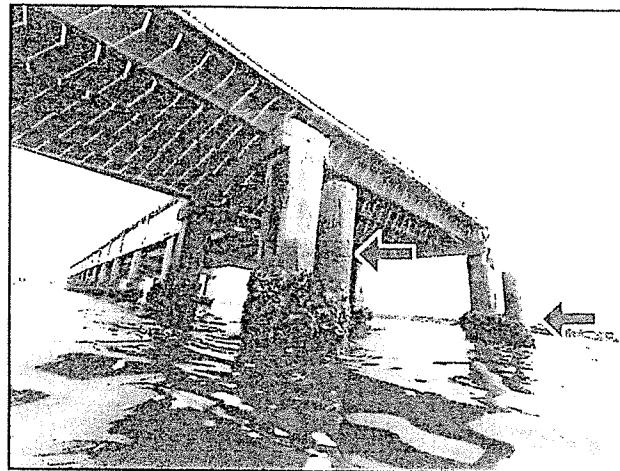
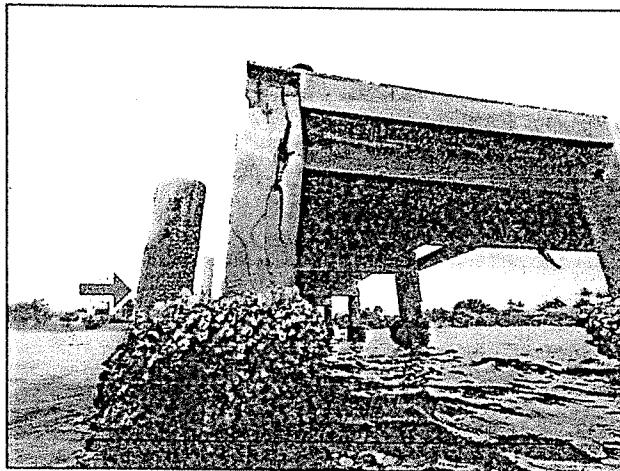
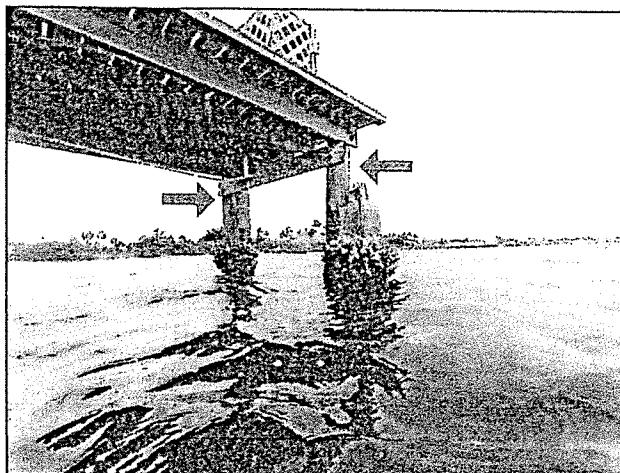
There are also some wood piles installed at the end of the dock to serve as temporary support for old concrete piles that collapsed. Those wood piles are intended to be temporary and should not be considered as permanent solution. Recommend those wood piles be removed and replaced by qualified marine contractor.

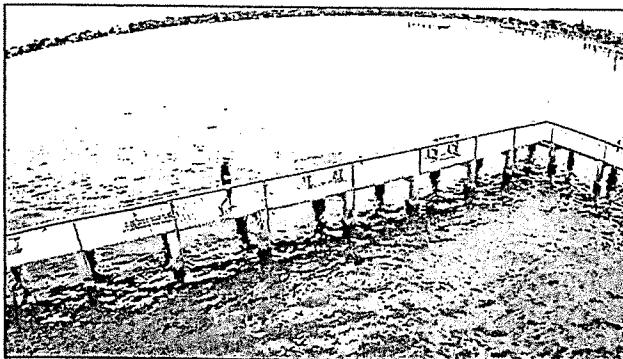
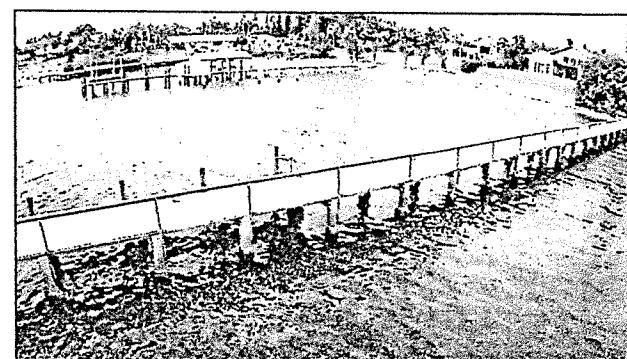
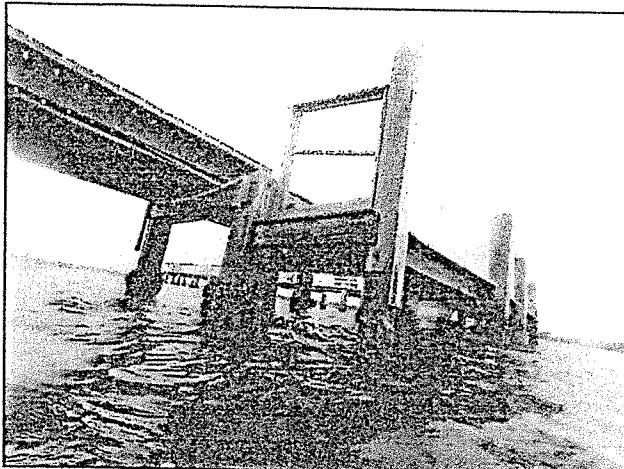
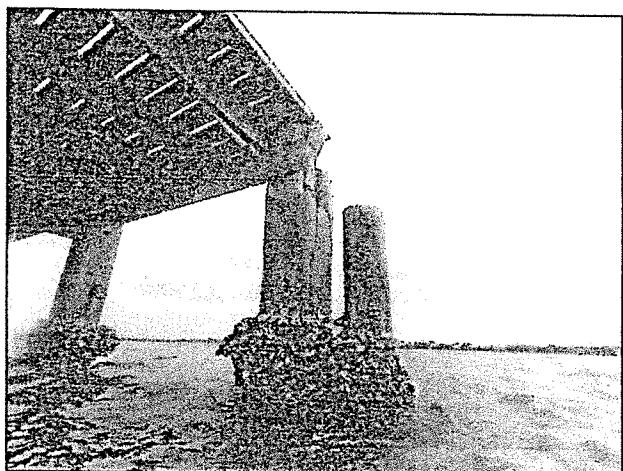
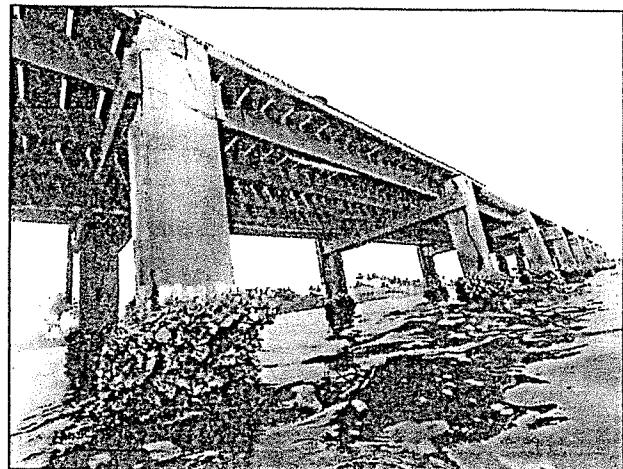
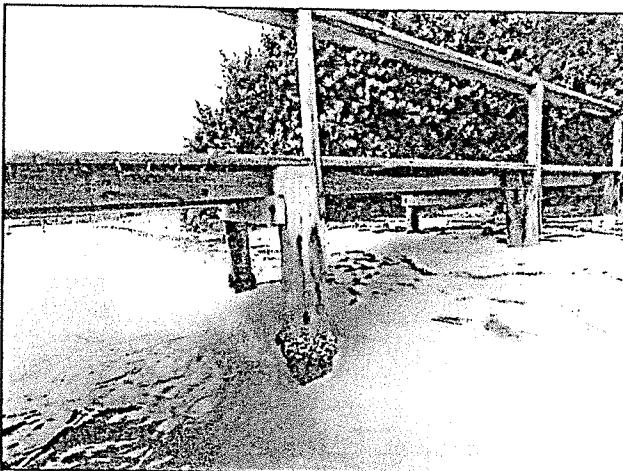
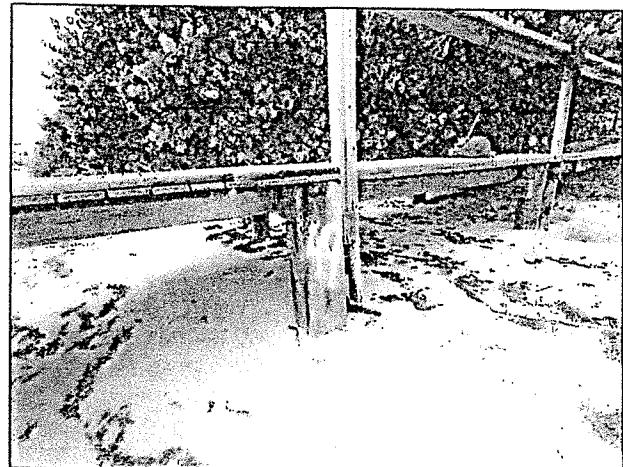
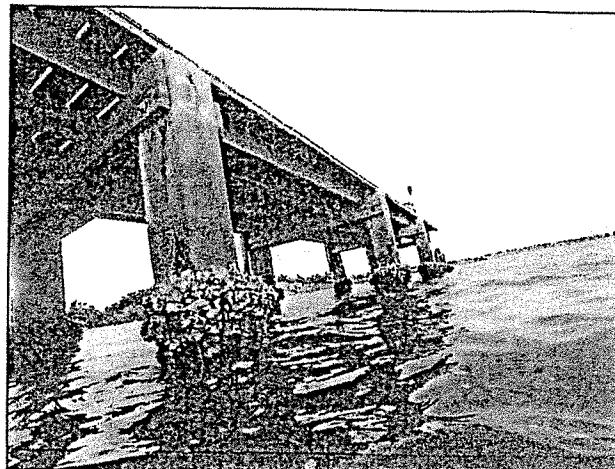
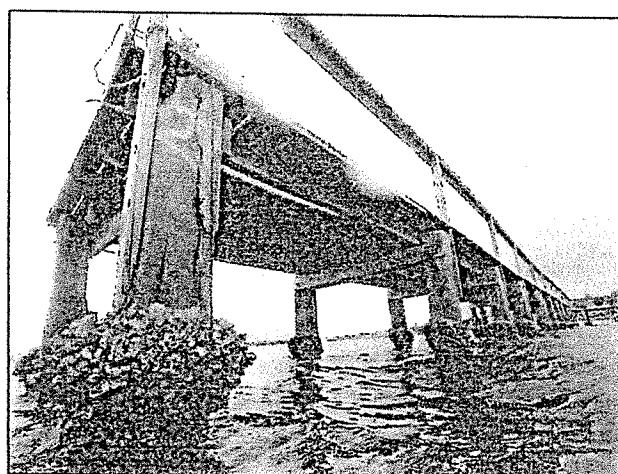
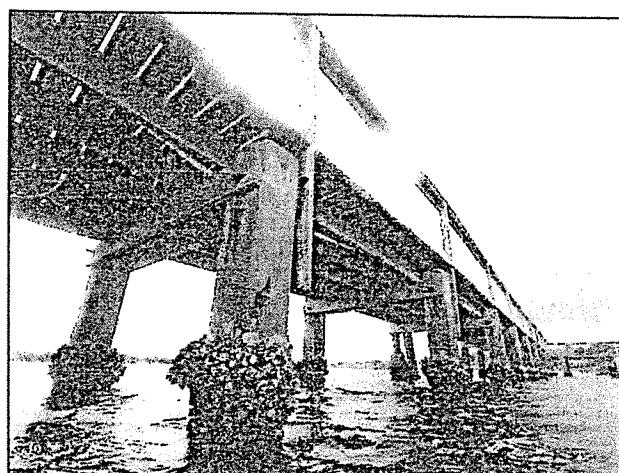
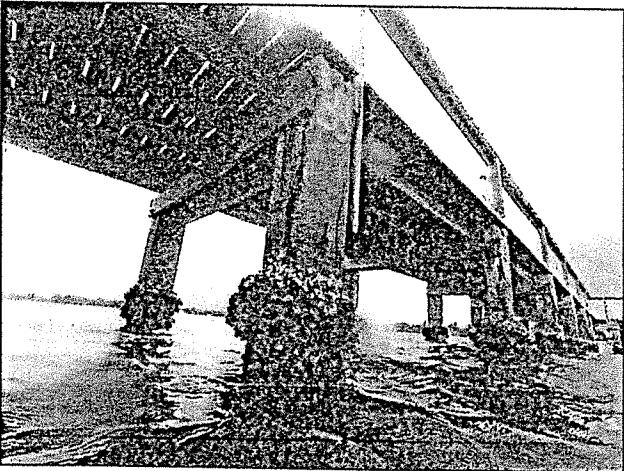
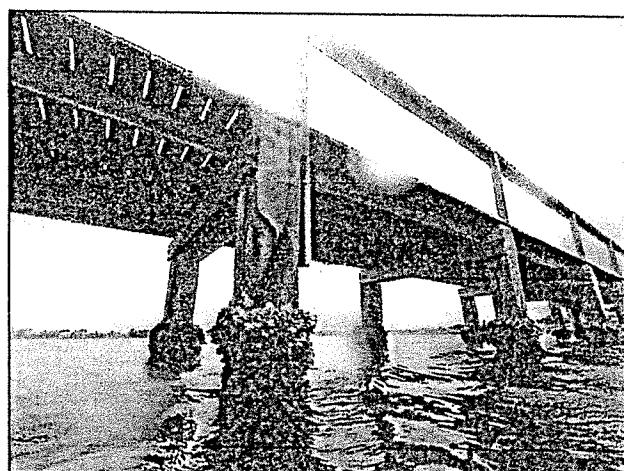
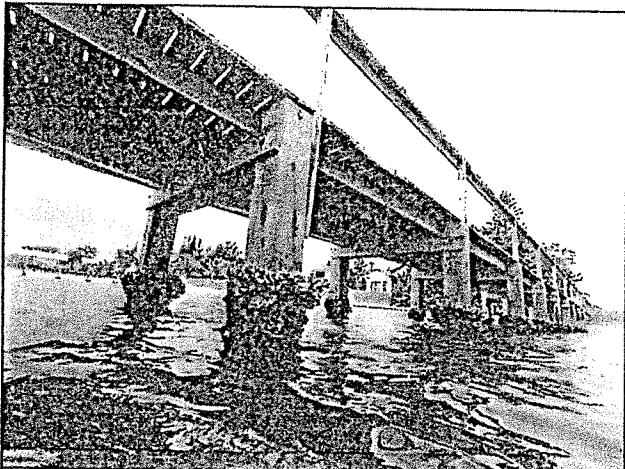
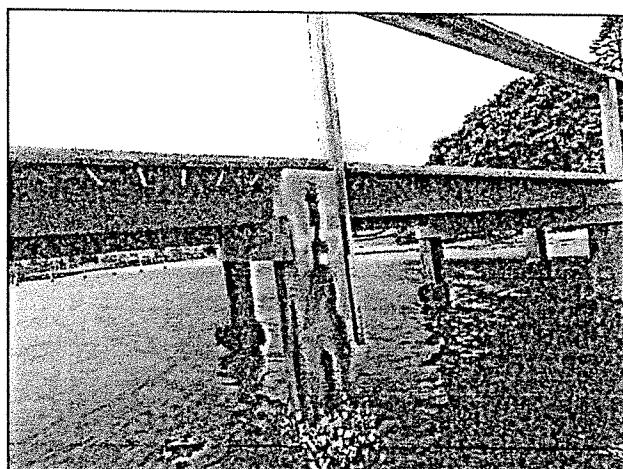
The top of the concrete piles are exposed to the greatest amount of movement (pressure) caused by wave and wind action. Therefore, when the dock moves (or is shaken), due to effects of wave and wind action, the concrete crack and expose the steel rebars inside. When left unattended for long periods of time, the steel rebar corrodes and expands causing further deterioration and weakening of the structure.

There are approximately 76 concrete piles supporting this 400 lineal feet dock. Inspector counted 49 of them in severe stage of deterioration. Most of the damaged concrete piles are beyond repair and should be replaced in its entirety. All work should be performed by a qualified marine contractor.

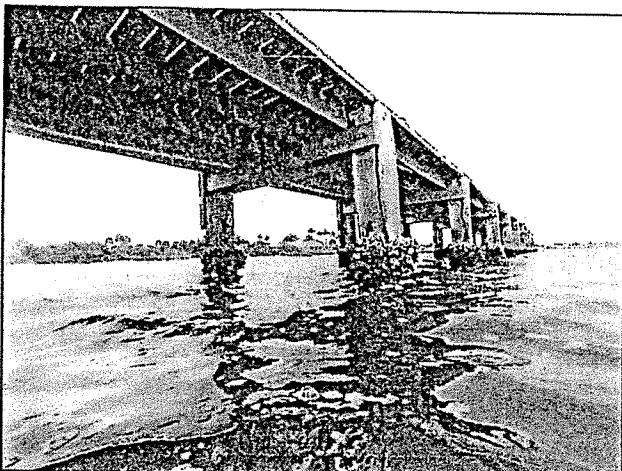
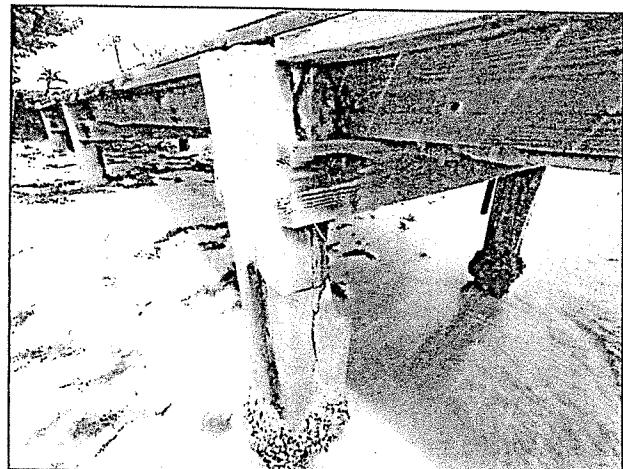
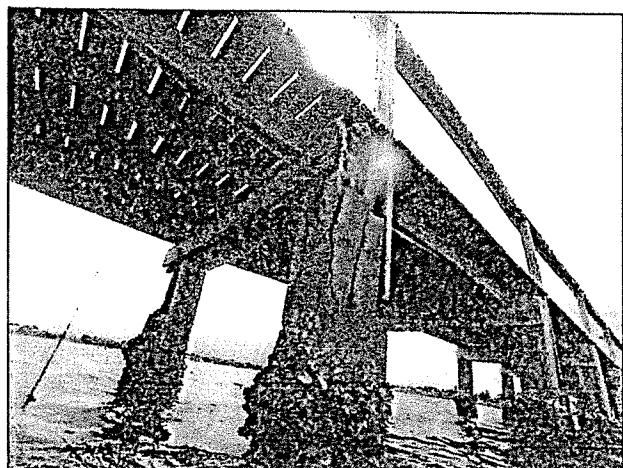
The beams are the underlying support to the deck planks. This composite deck boards are attached to three beams which are made of pressure treated marine lumber. Inspector found no deficiencies with the condition of the beams at the time of the inspection.
